**REPORT
of the
INVESTIGATION BOARD
for the
UNPLANNED FIRE
at the
LIQUEFIED GASEOUS FUELS
SPILL TEST FACILITY
on
AUGUST 29, 1987**

REPORT OF THE
INVESTIGATION BOARD FOR
THE UNPLANNED FIRE AT THE
LIQUEFIED GASEOUS FUELS SPILL TEST FACILITY
ON AUGUST 29, 1987

OCTOBER 23, 1987

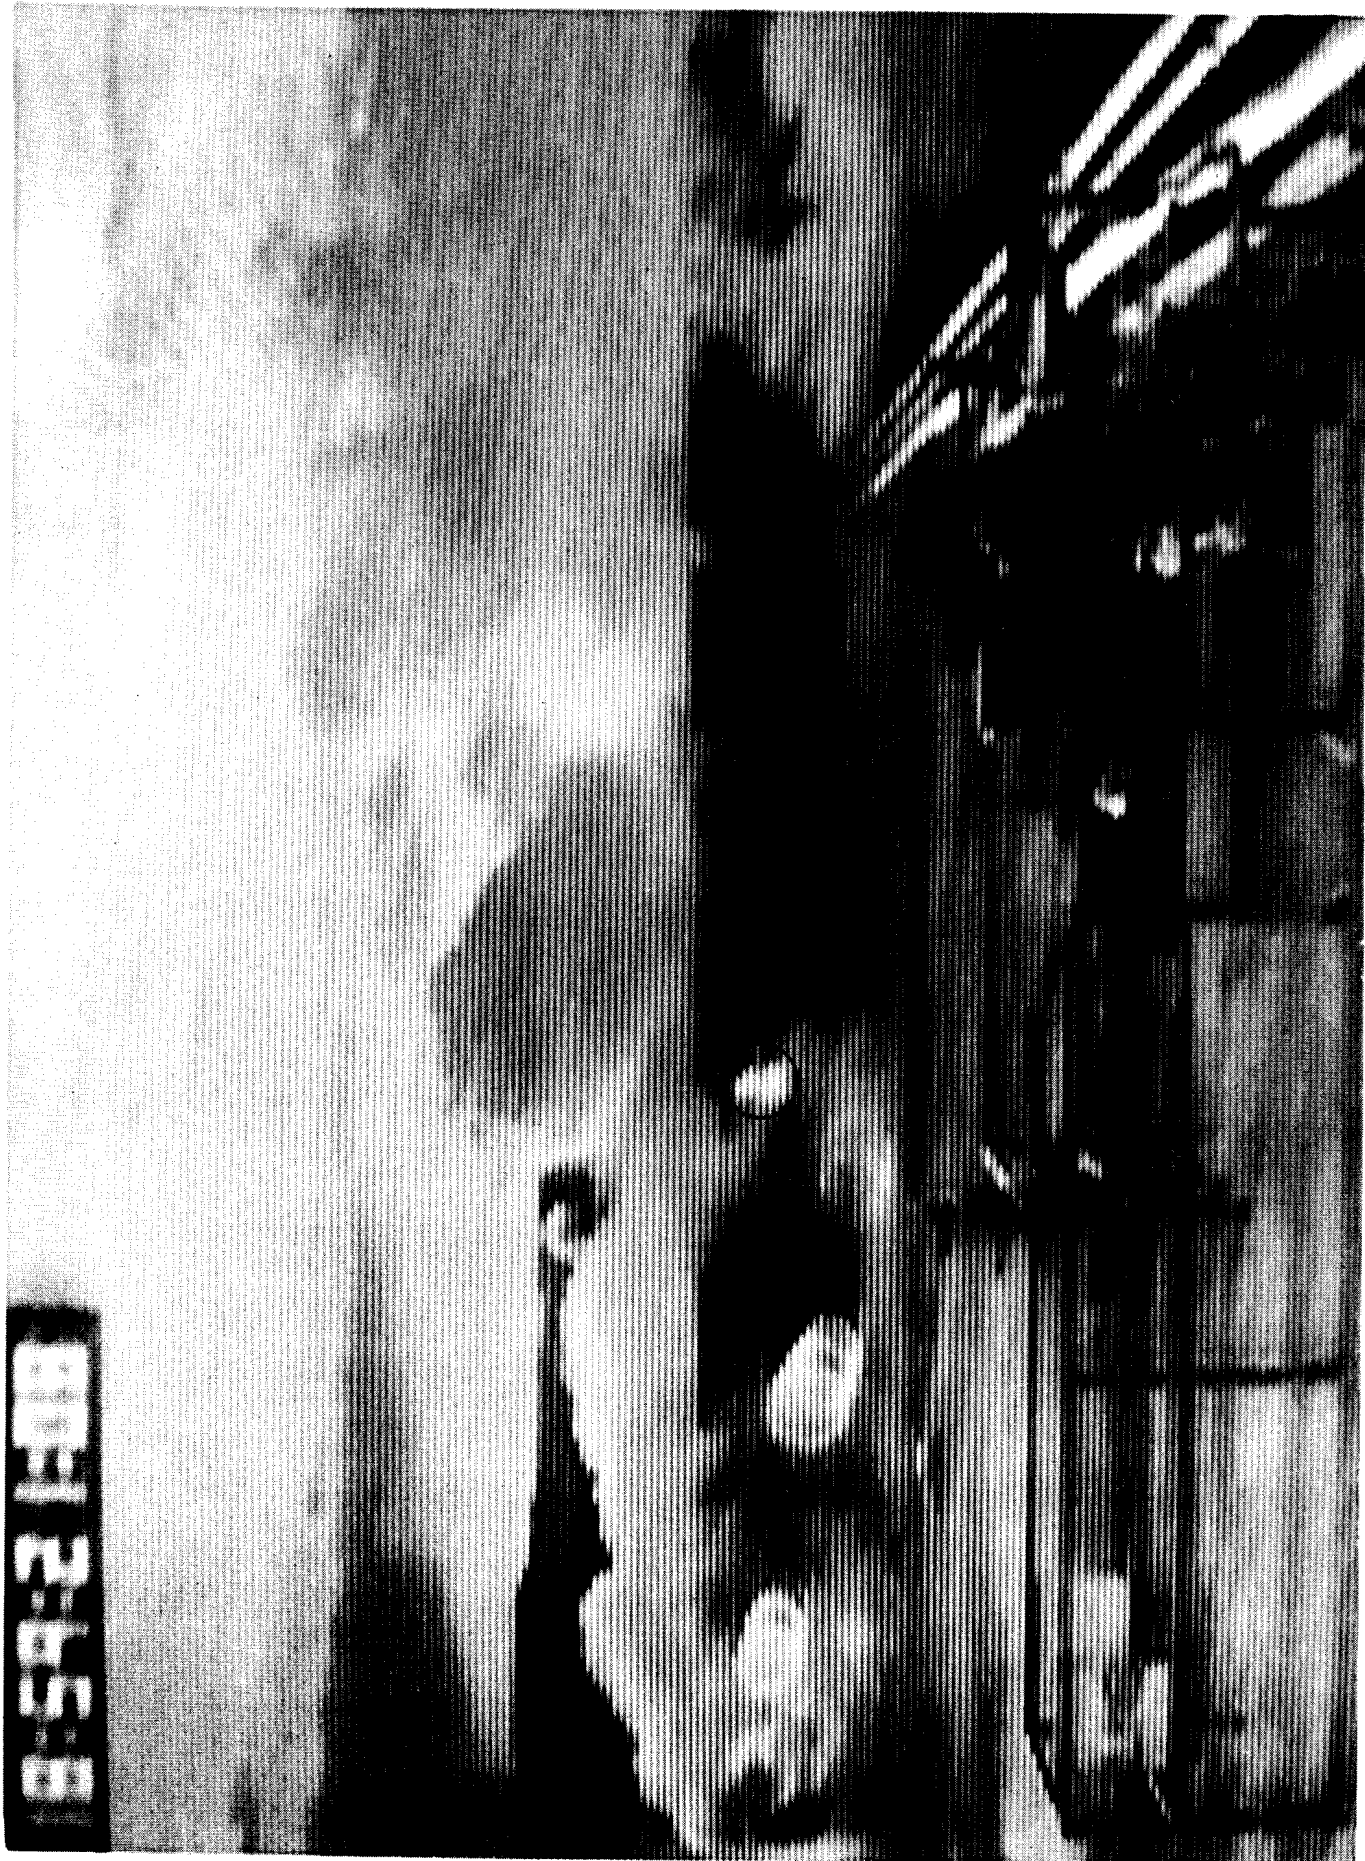
9. Ignition appears to have occurred at 18:59:21:08 (based on images from video camera 2) or 1 minute, 16 seconds into test. Figures 4a through 4s show the sequence of photos taken by the three video cameras and movie camera 1 from just before ignition to just after ignition.

**SPILL TEST AREA: VIDEO CAMERA 2
AT IGNITION**
FIGURE 4j

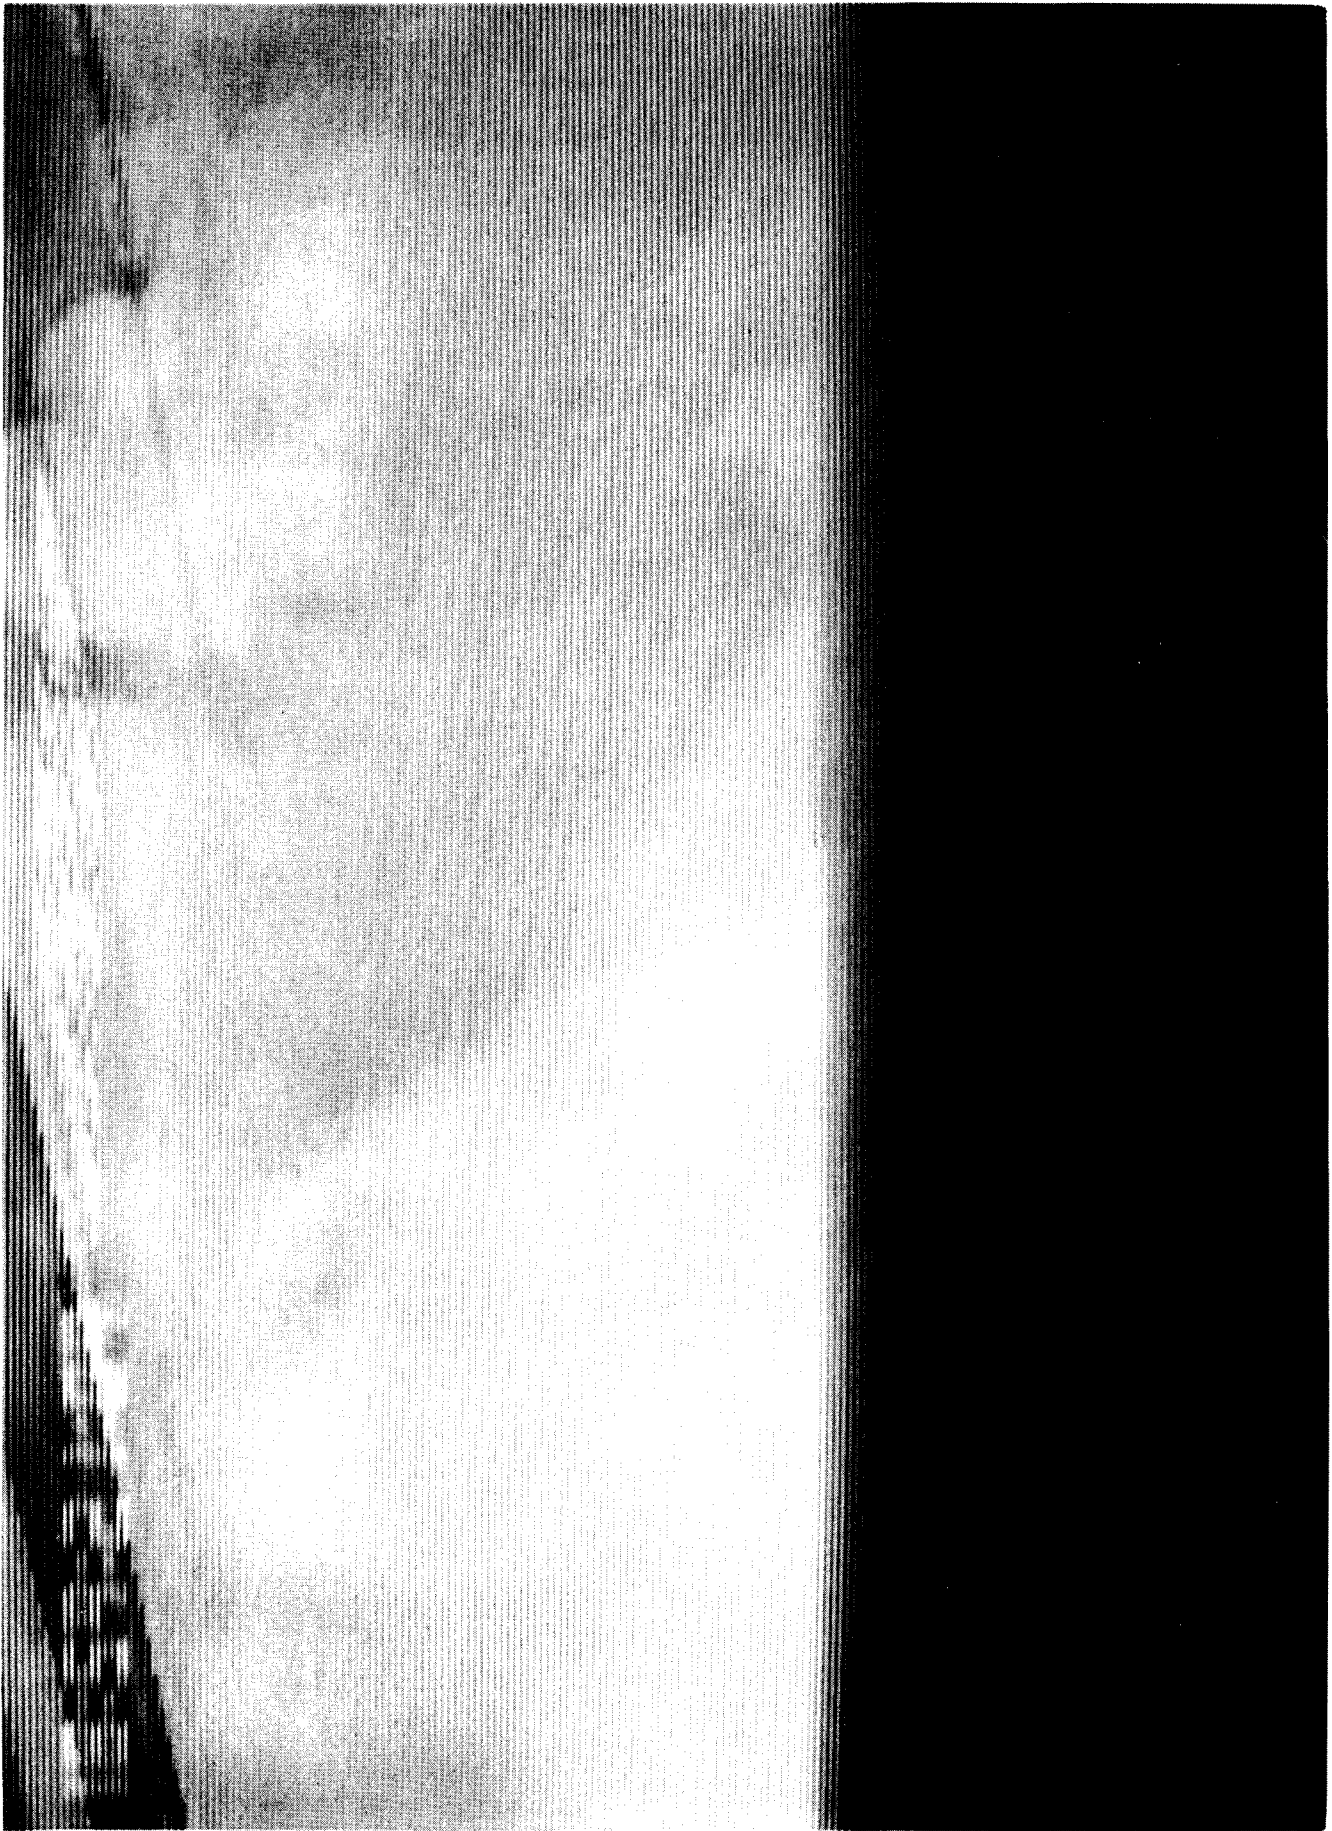
**SPILL TEST AREA: VIDEO CAMERA 3
1/30 OF SECOND AFTER IGNITION**
FIGURE 4n

17. At pole 4, interior guy wire support (chain) had instrumentation wiring pressed against it, with each cable stripped approximately two inches. The signal cable from video camera 3 was broken at this point. Camera 3 lost its video signal in videotape frame 18:59:21:09, or one frame after ignition became visible outside the curtain. The force of the RPT disrupting the spill pond wall was the most likely cause of the broken signal cable. (Ref. Figure 4n for last partial frame).

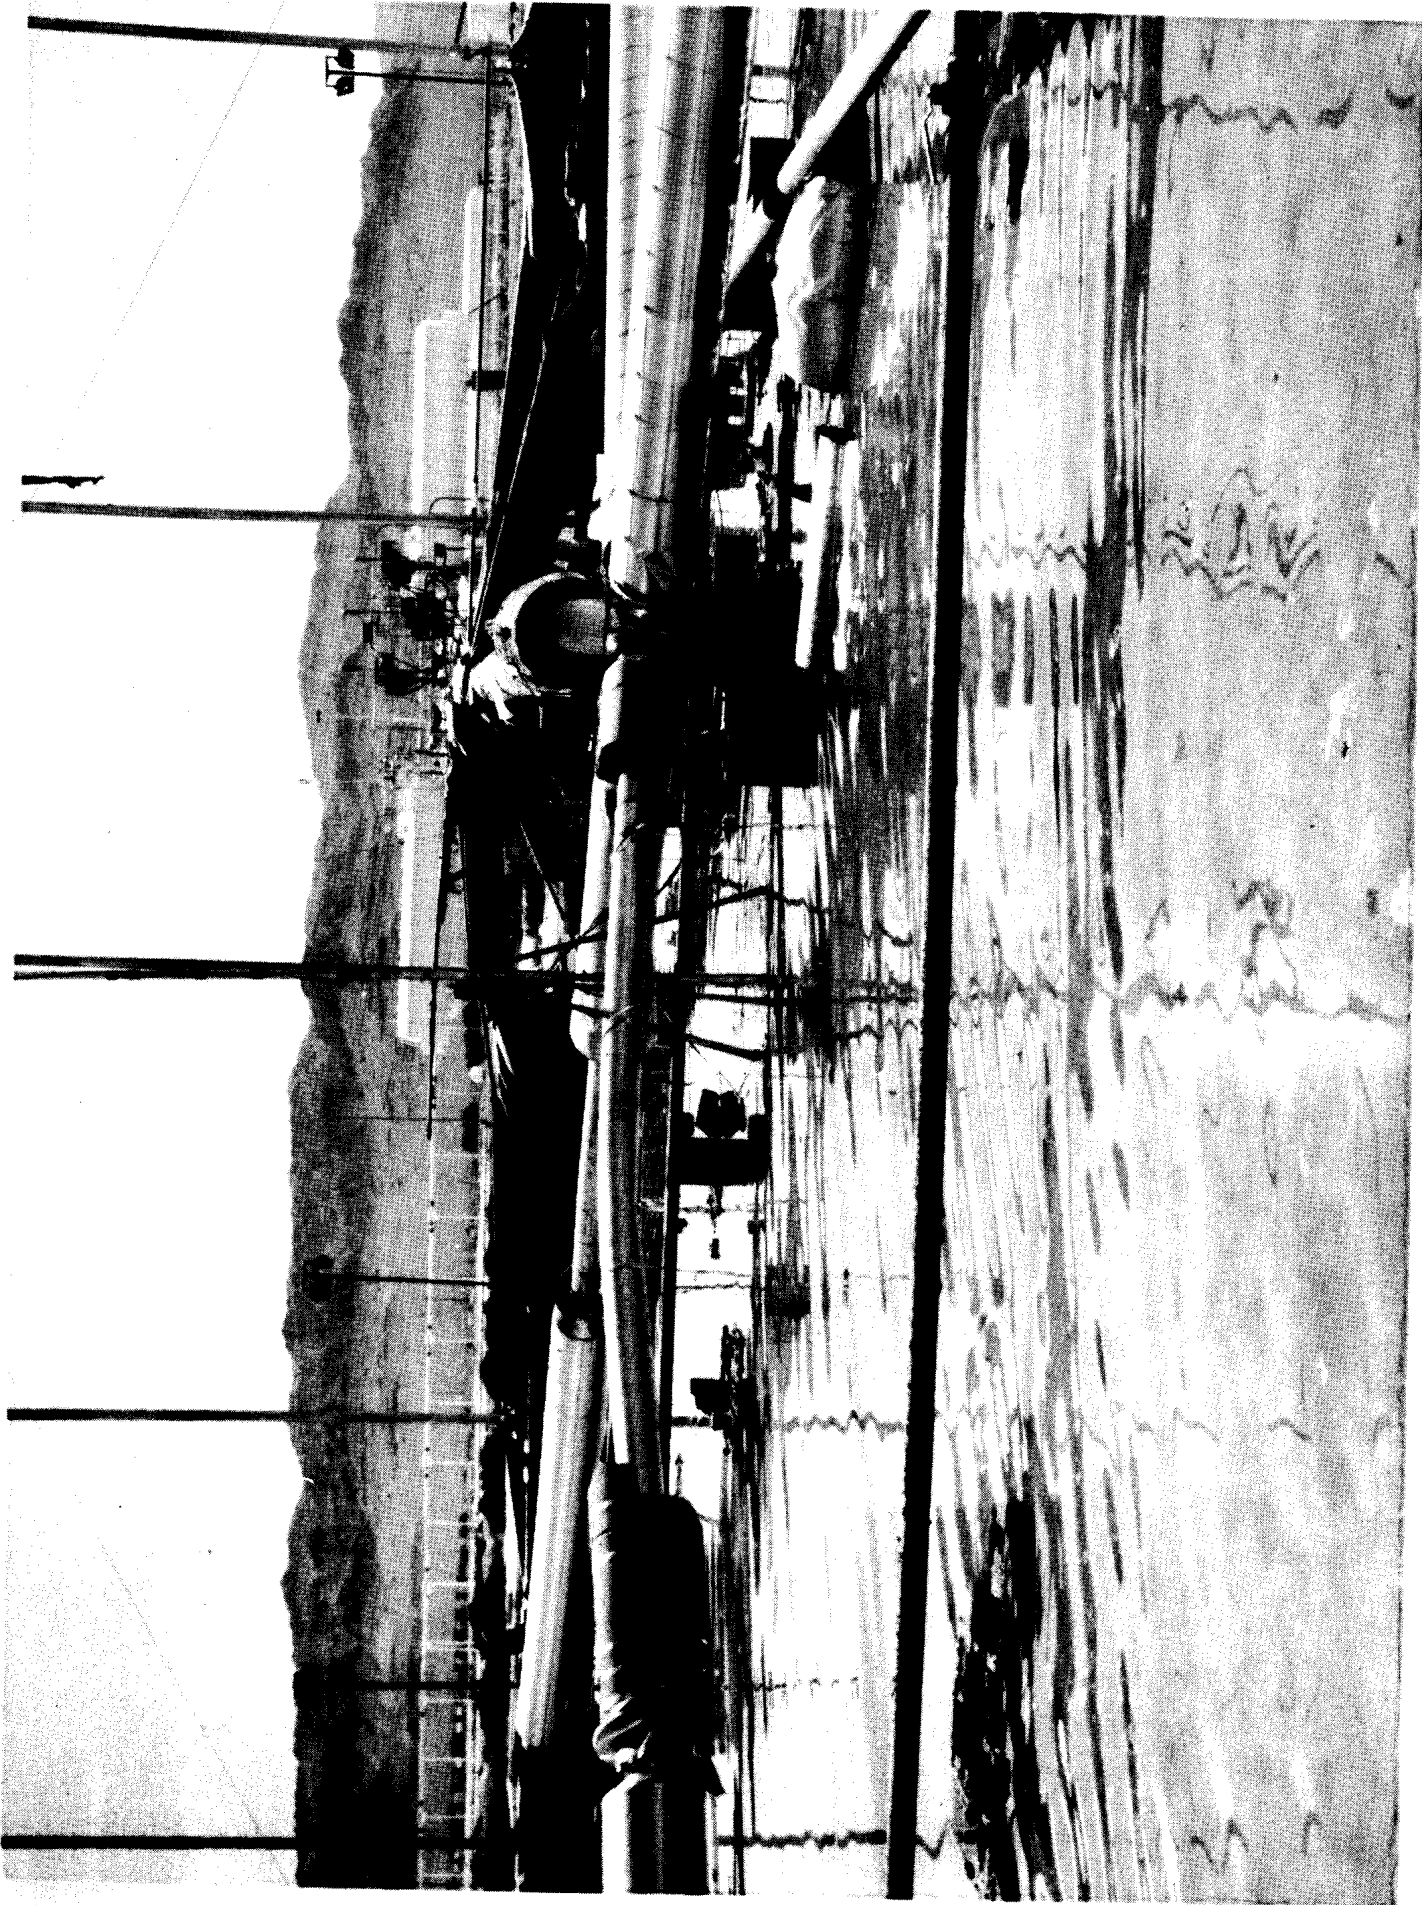
FIGURE 5

12. The spill-spider in the center of the pond was significantly damaged by the RPTs. Damage can be seen in Figure 5. For the general facility configuration, see Figure 1. Approximately 15 percent of the linear pipe length had the insulation blown off.

SPILL-SPIDER DAMAGE

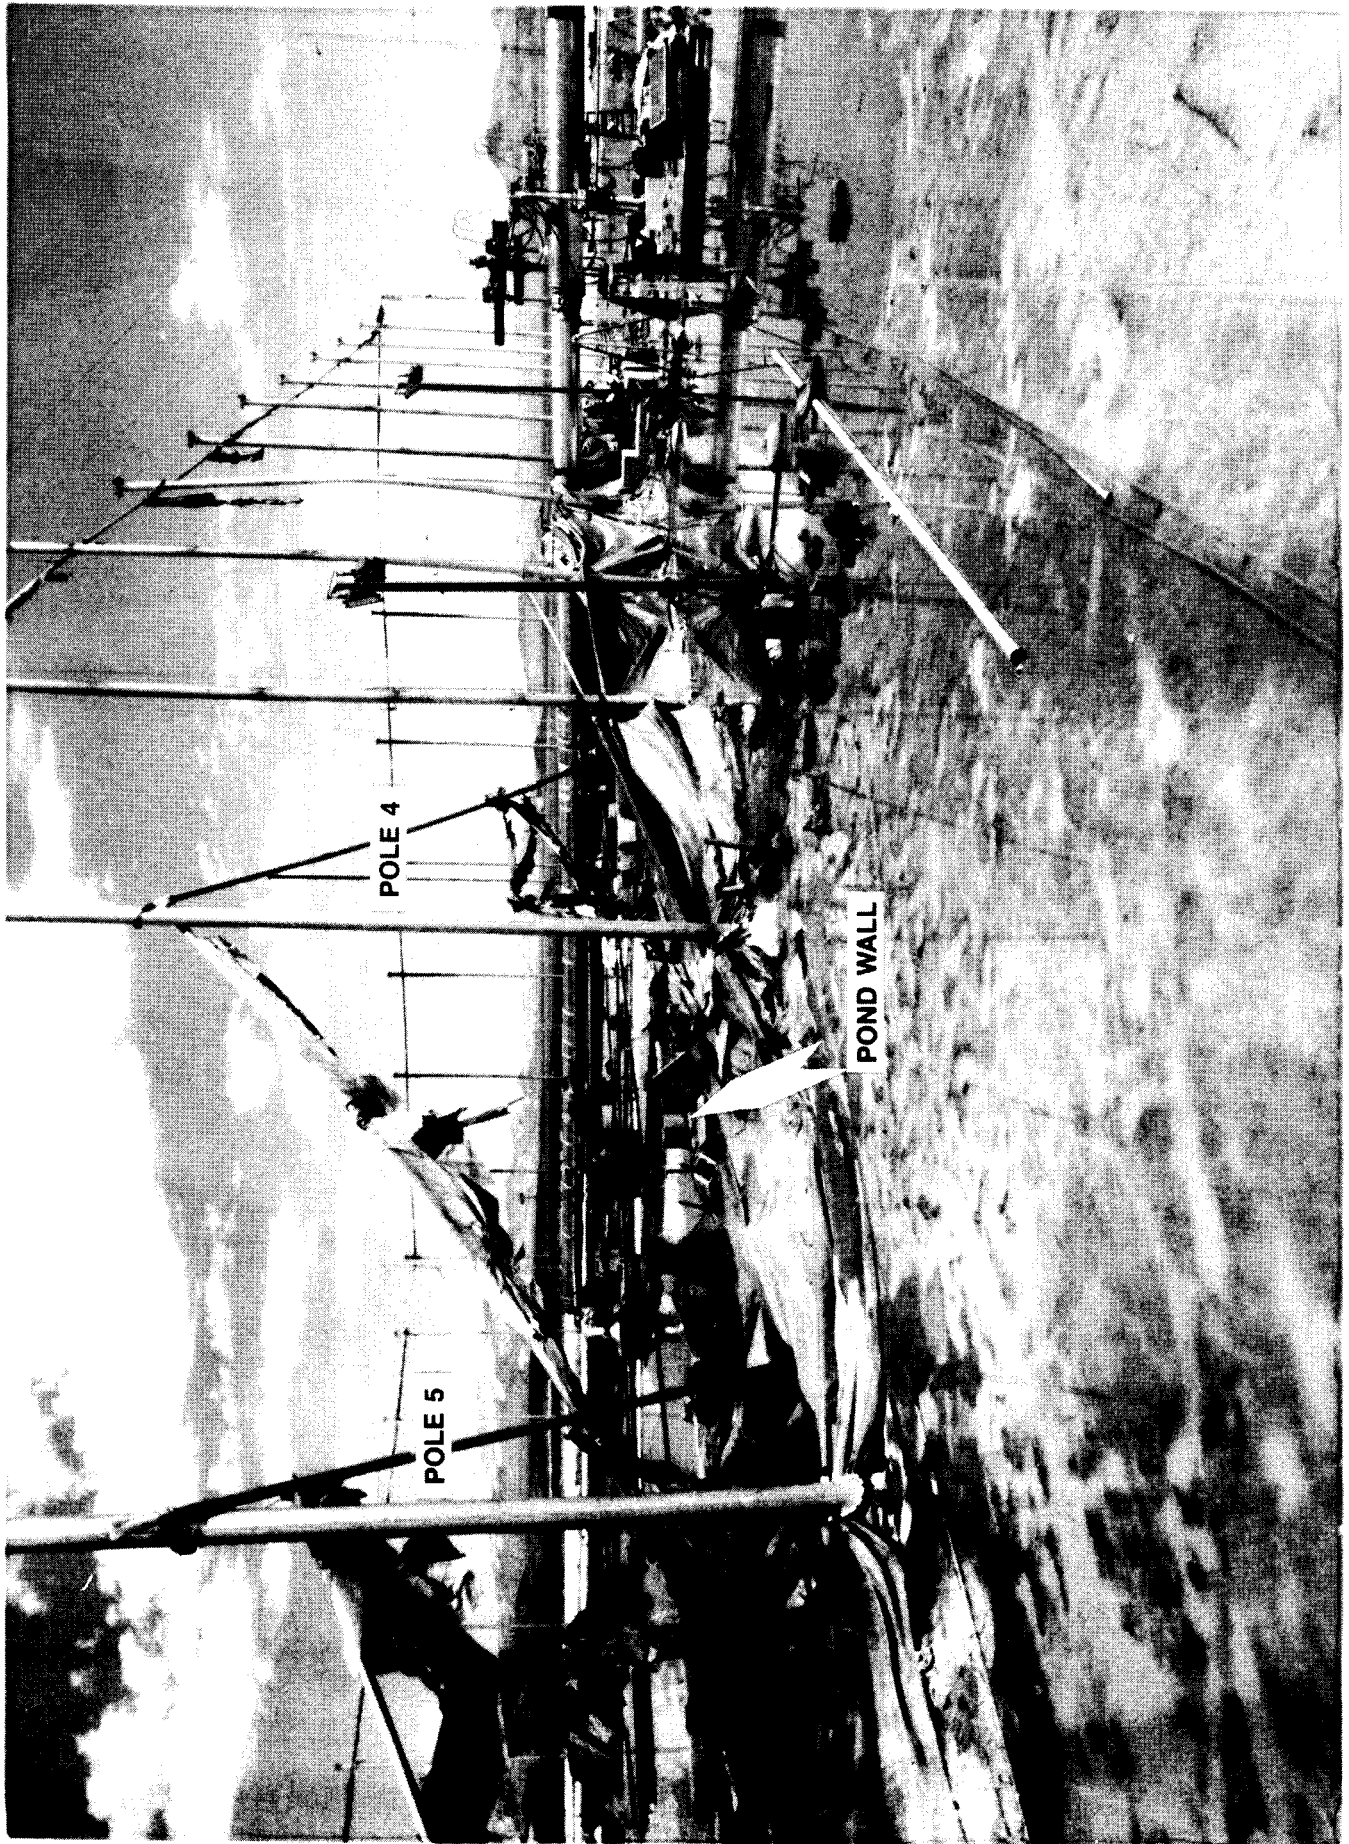
FIGURE 6a

13. In the location where the RPTs occurred on the edge of the pond, the concrete block wall was heavily damaged. Blocks were either pushed back over the earth-berm behind the block wall into the 7-ft-wide space between the pond and the vapor curtain or thrown completely beyond the vapor curtain. The 1/2-inch-diameter reinforcing rods used to align the concrete blocks in the vicinity of the fire ignition point were bent outward at an angle of 15° to 20°. The rods were not encased in concrete. Figure 6 provides several views of the damage at this point.

SPILL-POND WALL DAMAGE

3. Reduce the potential for creating a friction spark from mechanical impact actions of materials in the test area. Some specific actions that could be taken are the removal of the carbon steel reinforcing bar that is in the pond wall, cement the bricks in the pond wall to make it more difficult for them to be knocked out of position by nearby RPTs, and encase the stainless steel guy wires in plastic or teflon sleeves. With regard to the spillpond construction, cement could be eliminated if sandbags were used to weight the wall from the top and support it from behind. The chains at the bottom to which the stainless steel guy wires are connected should be covered with earth or protected by some means.

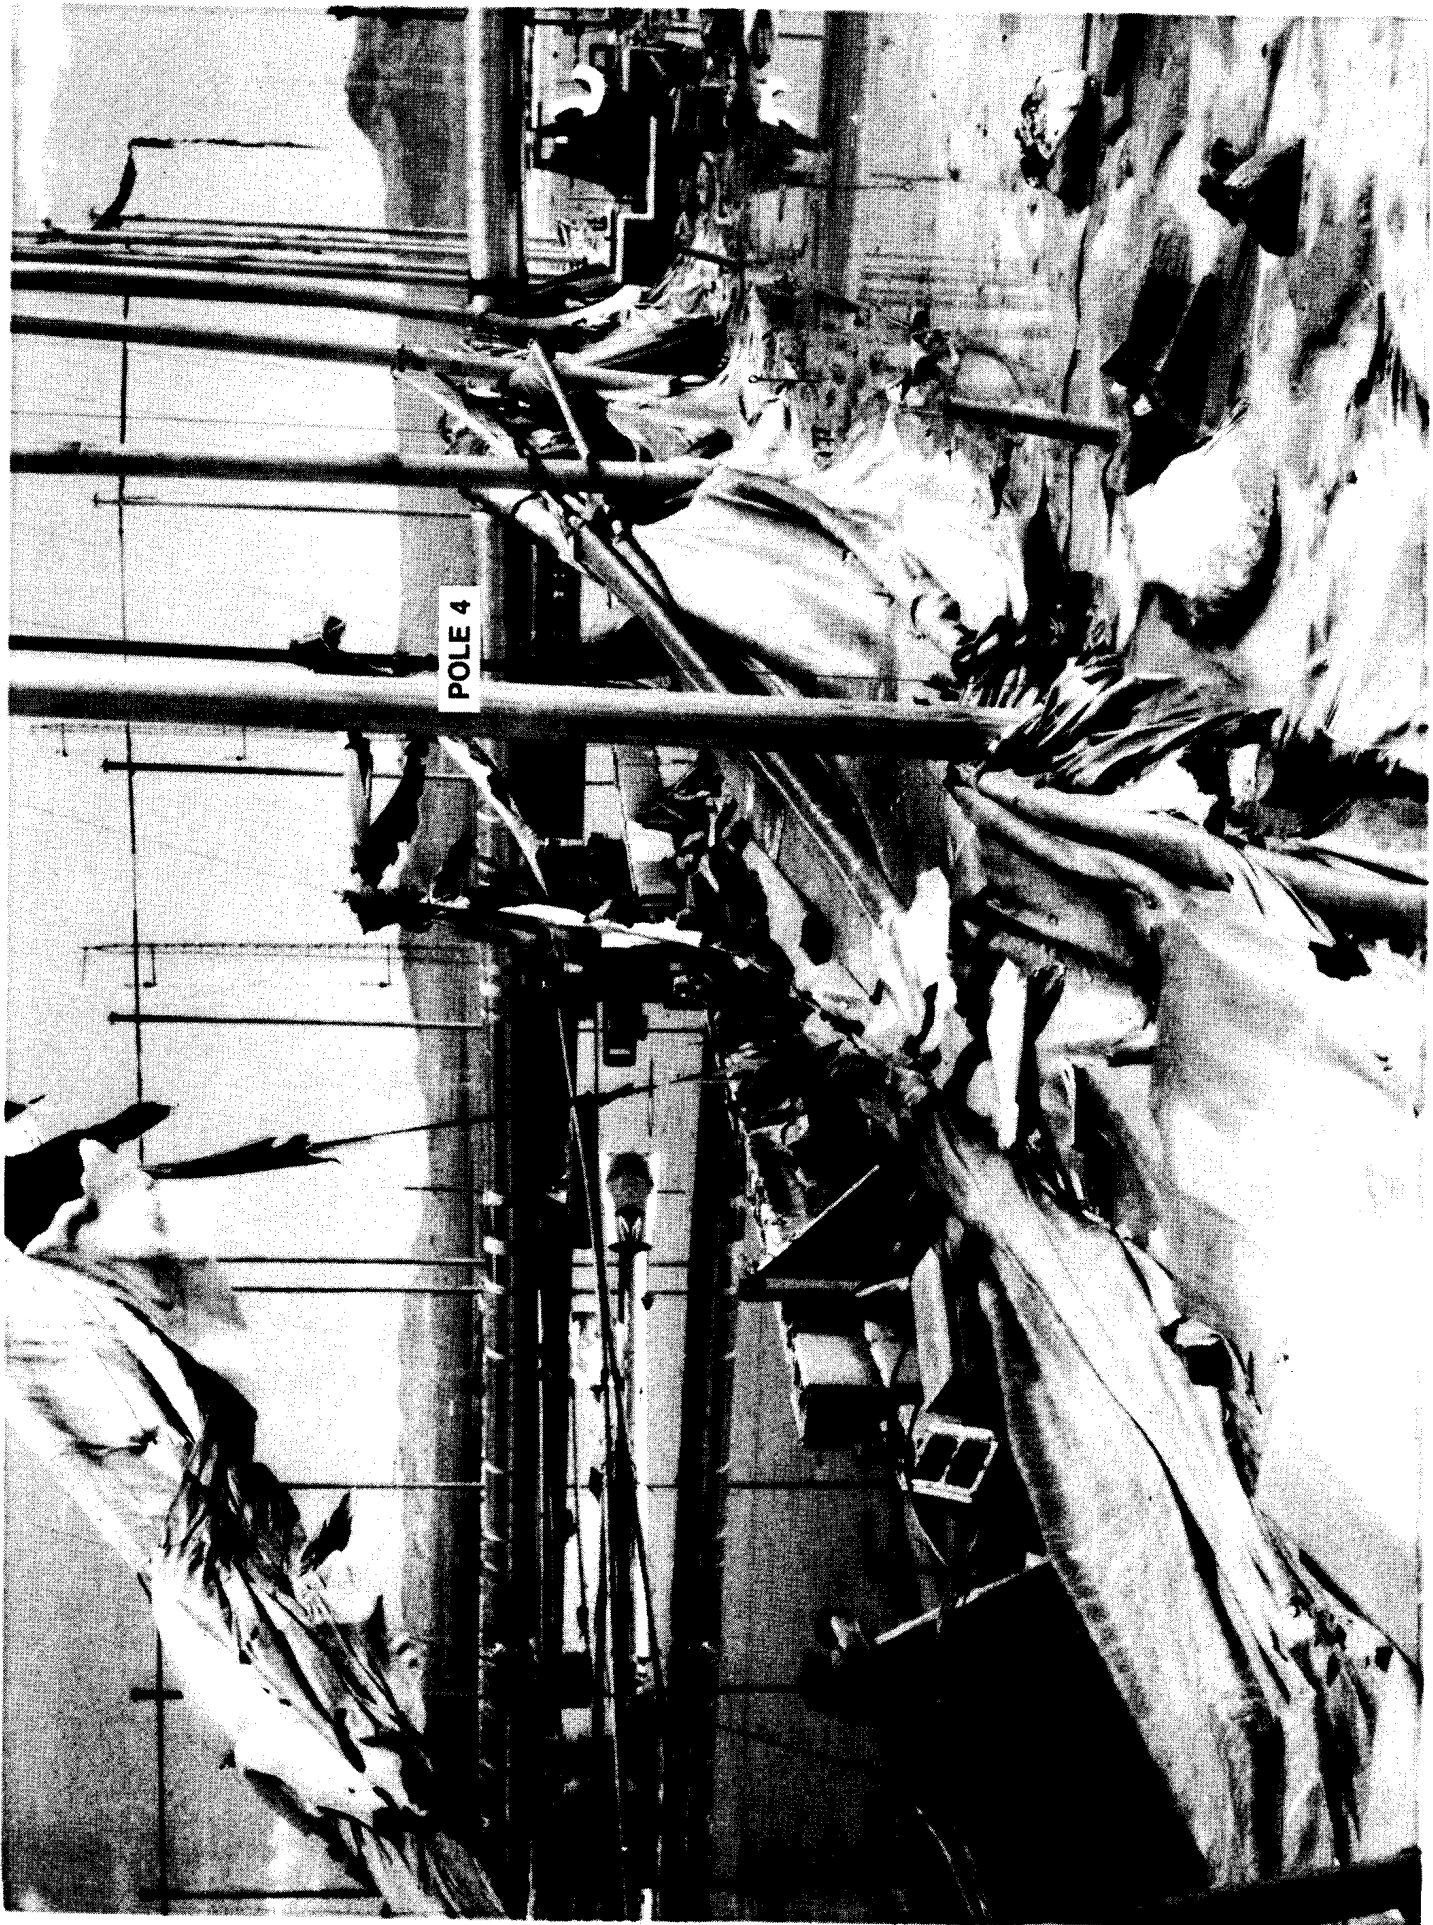
FIGURE 6b

SPILL-POND WALL DAMAGE

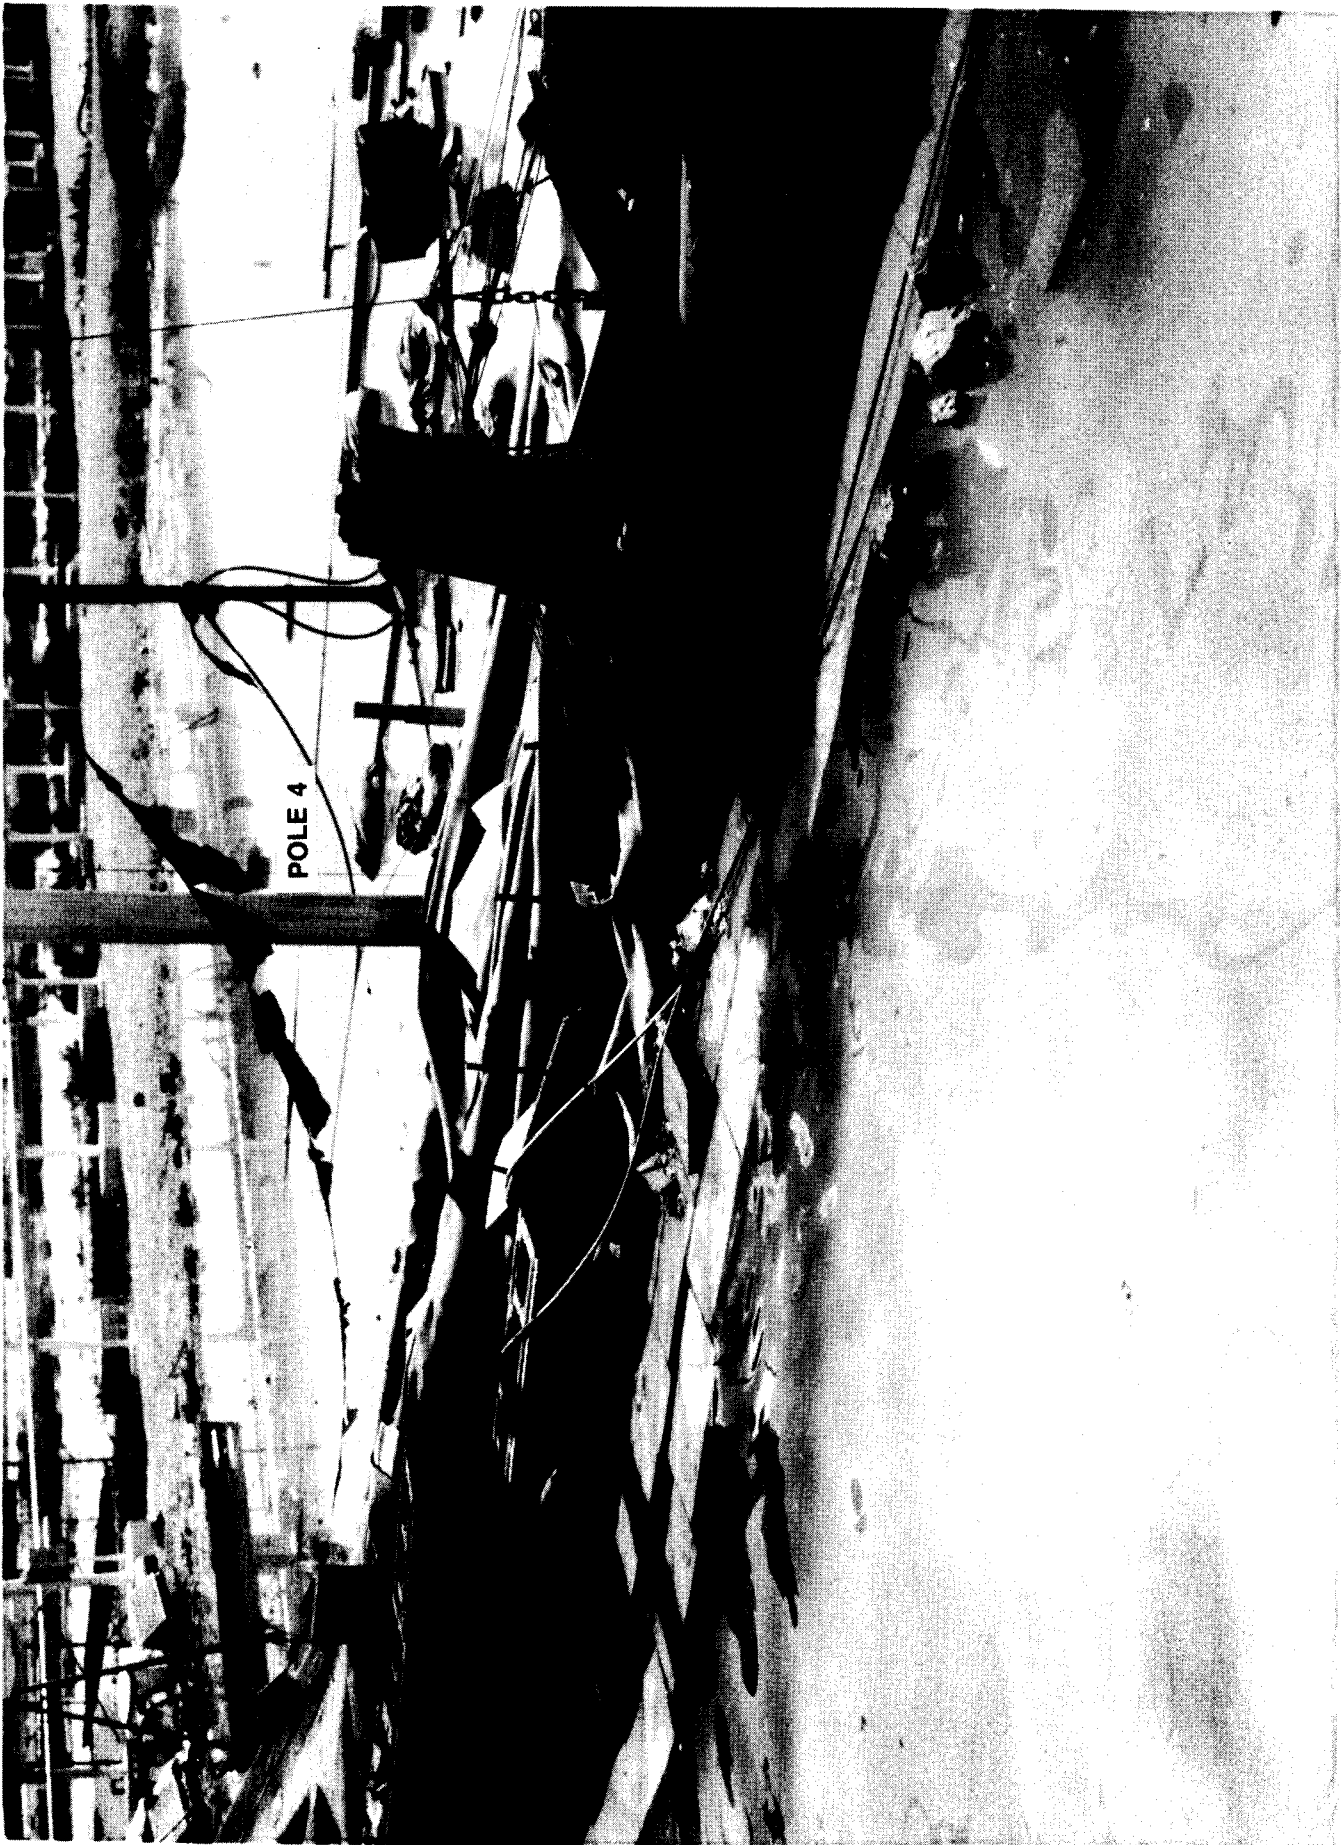
FIGURE 6c

SPILL-POND WALL DAMAGE

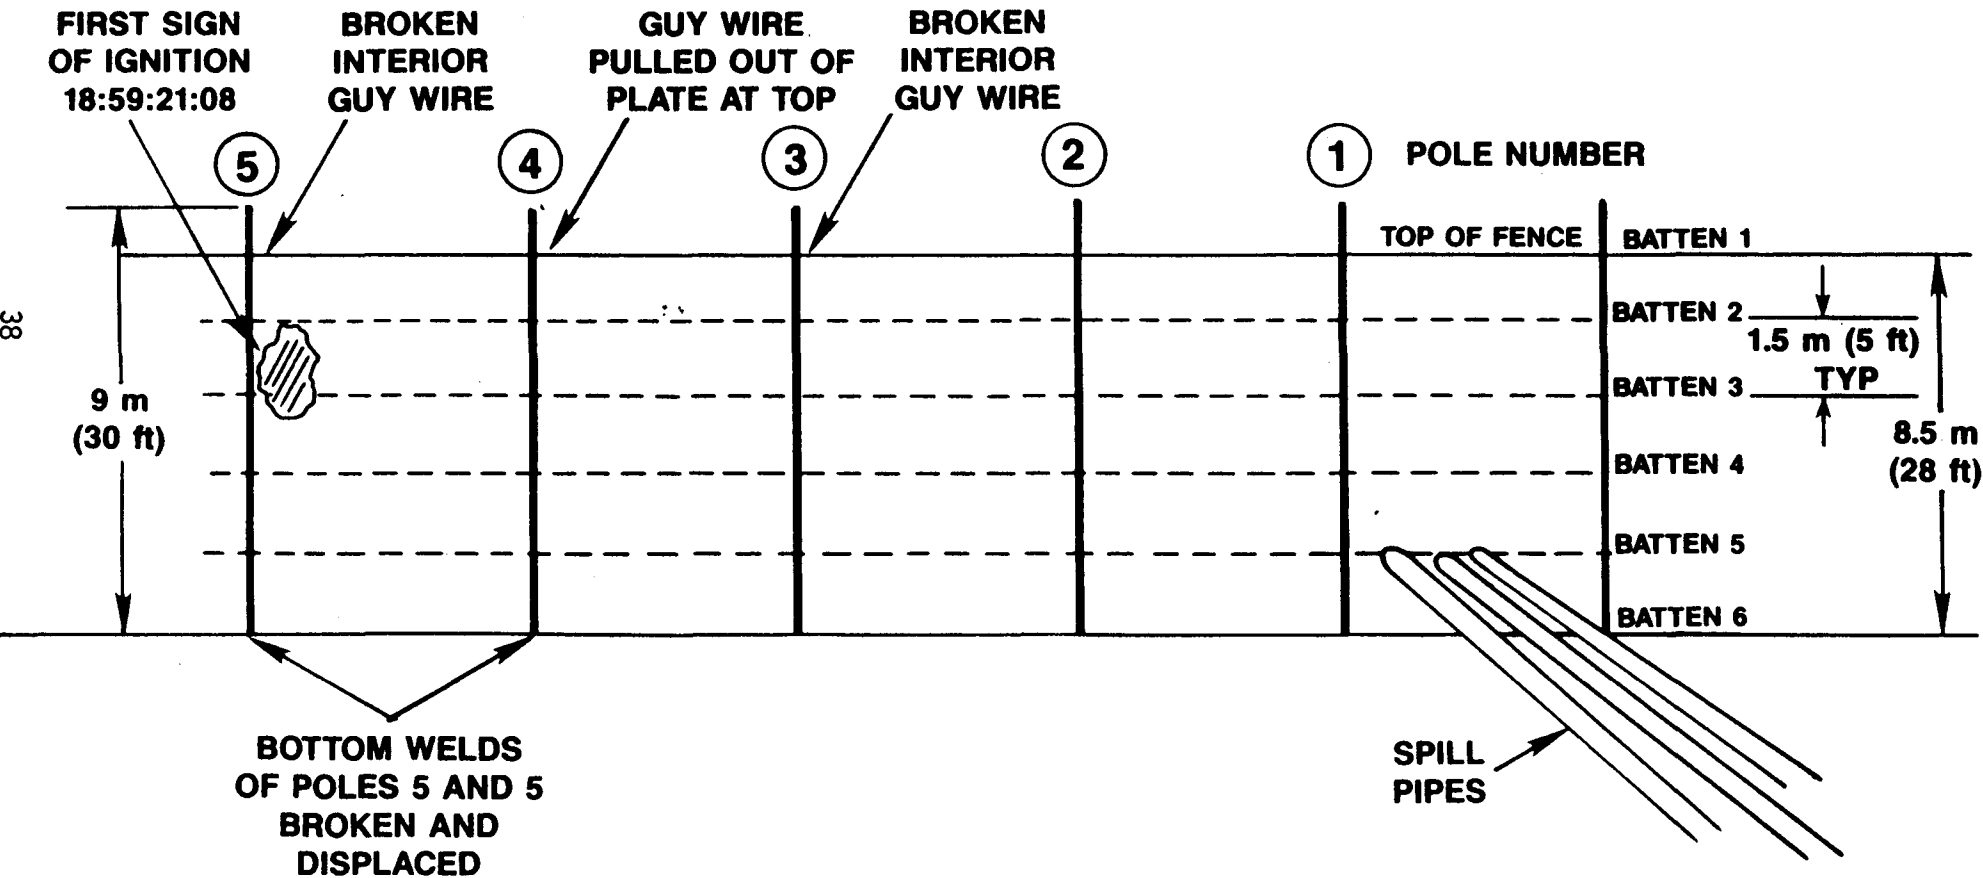
FIGURE 7

18. Aluminum battens 2, 4, 5, and 6 (Ref. Figure 7) in the support structure between poles 4 and 5 were found broken and separated at approximately 1/3 the distance into the curtain from pole 4. At the breaking points, aluminum was broken as if from bending.

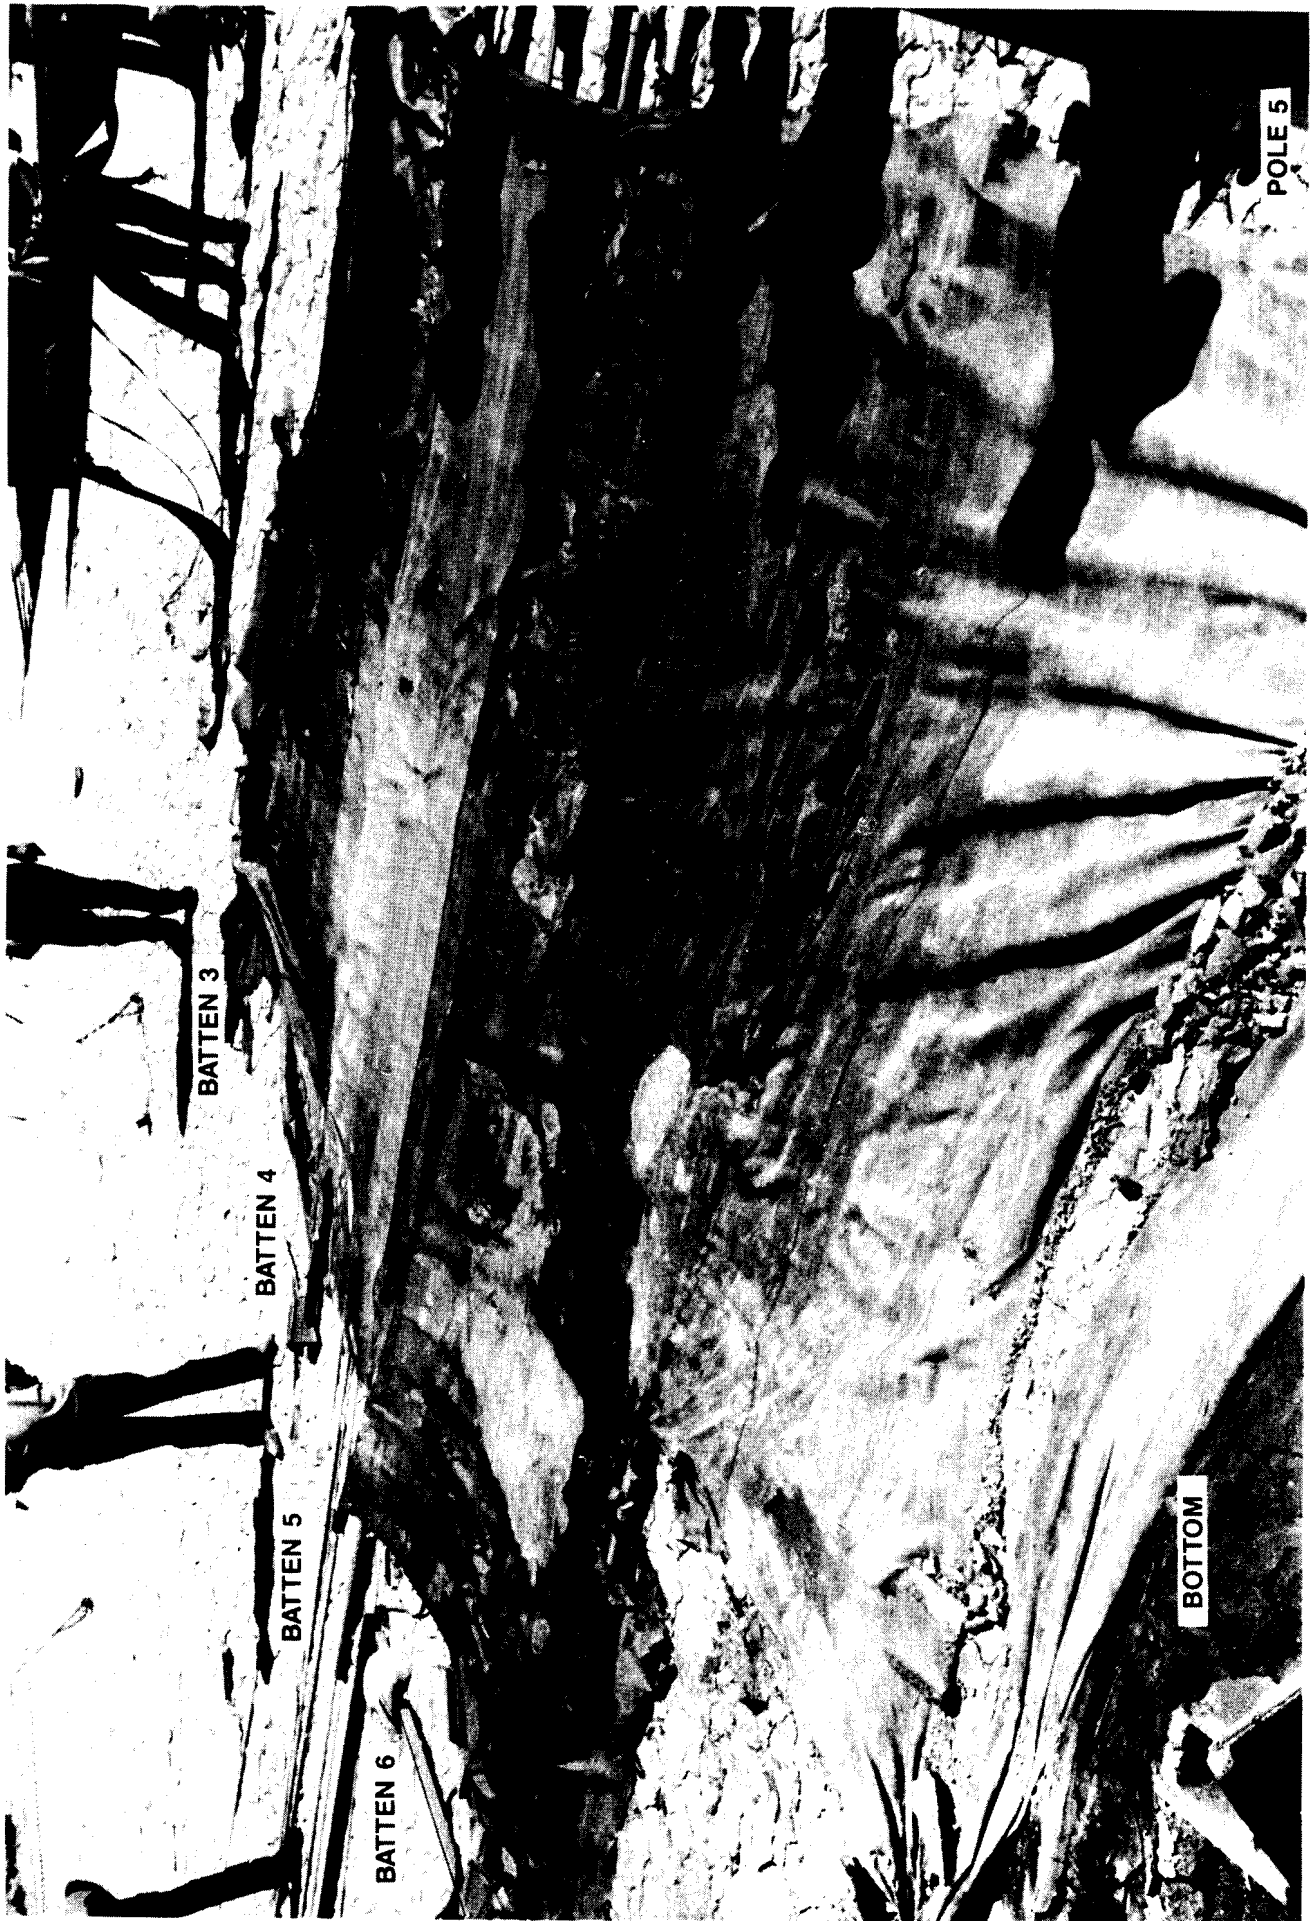
FIGURE 8

14. Several pieces of block (approximately 2 pounds each) were found directly east of the spill test area approximately 130 feet away from the fence.
15. The vapor curtain between poles 4 and 5 was generally intact below the third batten (counting from the top--see Figure 7). Above the third batten, little remained of the curtain. The final status of the curtain can be seen in Figure 8.

VAPOR CURTAIN AFTER FIRE

2. Reduce the potential for creating a static electric charge or static spark. This could be accomplished by utilizing a vapor curtain that is electrically conductive and grounded. If an electrically conductive curtain cannot be found, then the battens used to stiffen the curtain should be electrically bonded and grounded. Locations of electrical ground should be well controlled; the diameter of guy wires could be increased to minimize potential for breaking and producing a highly mobile ground that could contribute to a random discharge of a static electric charge.
