**REPORT
of the
INVESTIGATION BOARD
for the
UNPLANNED FIRE
at the
LIQUEFIED GASEOUS FUELS
SPILL TEST FACILITY
on
AUGUST 29, 1987**

REPORT OF THE
INVESTIGATION BOARD FOR
THE UNPLANNED FIRE AT THE
LIQUEFIED GASEOUS FUELS SPILL TEST FACILITY
ON AUGUST 29, 1987

OCTOBER 23, 1987

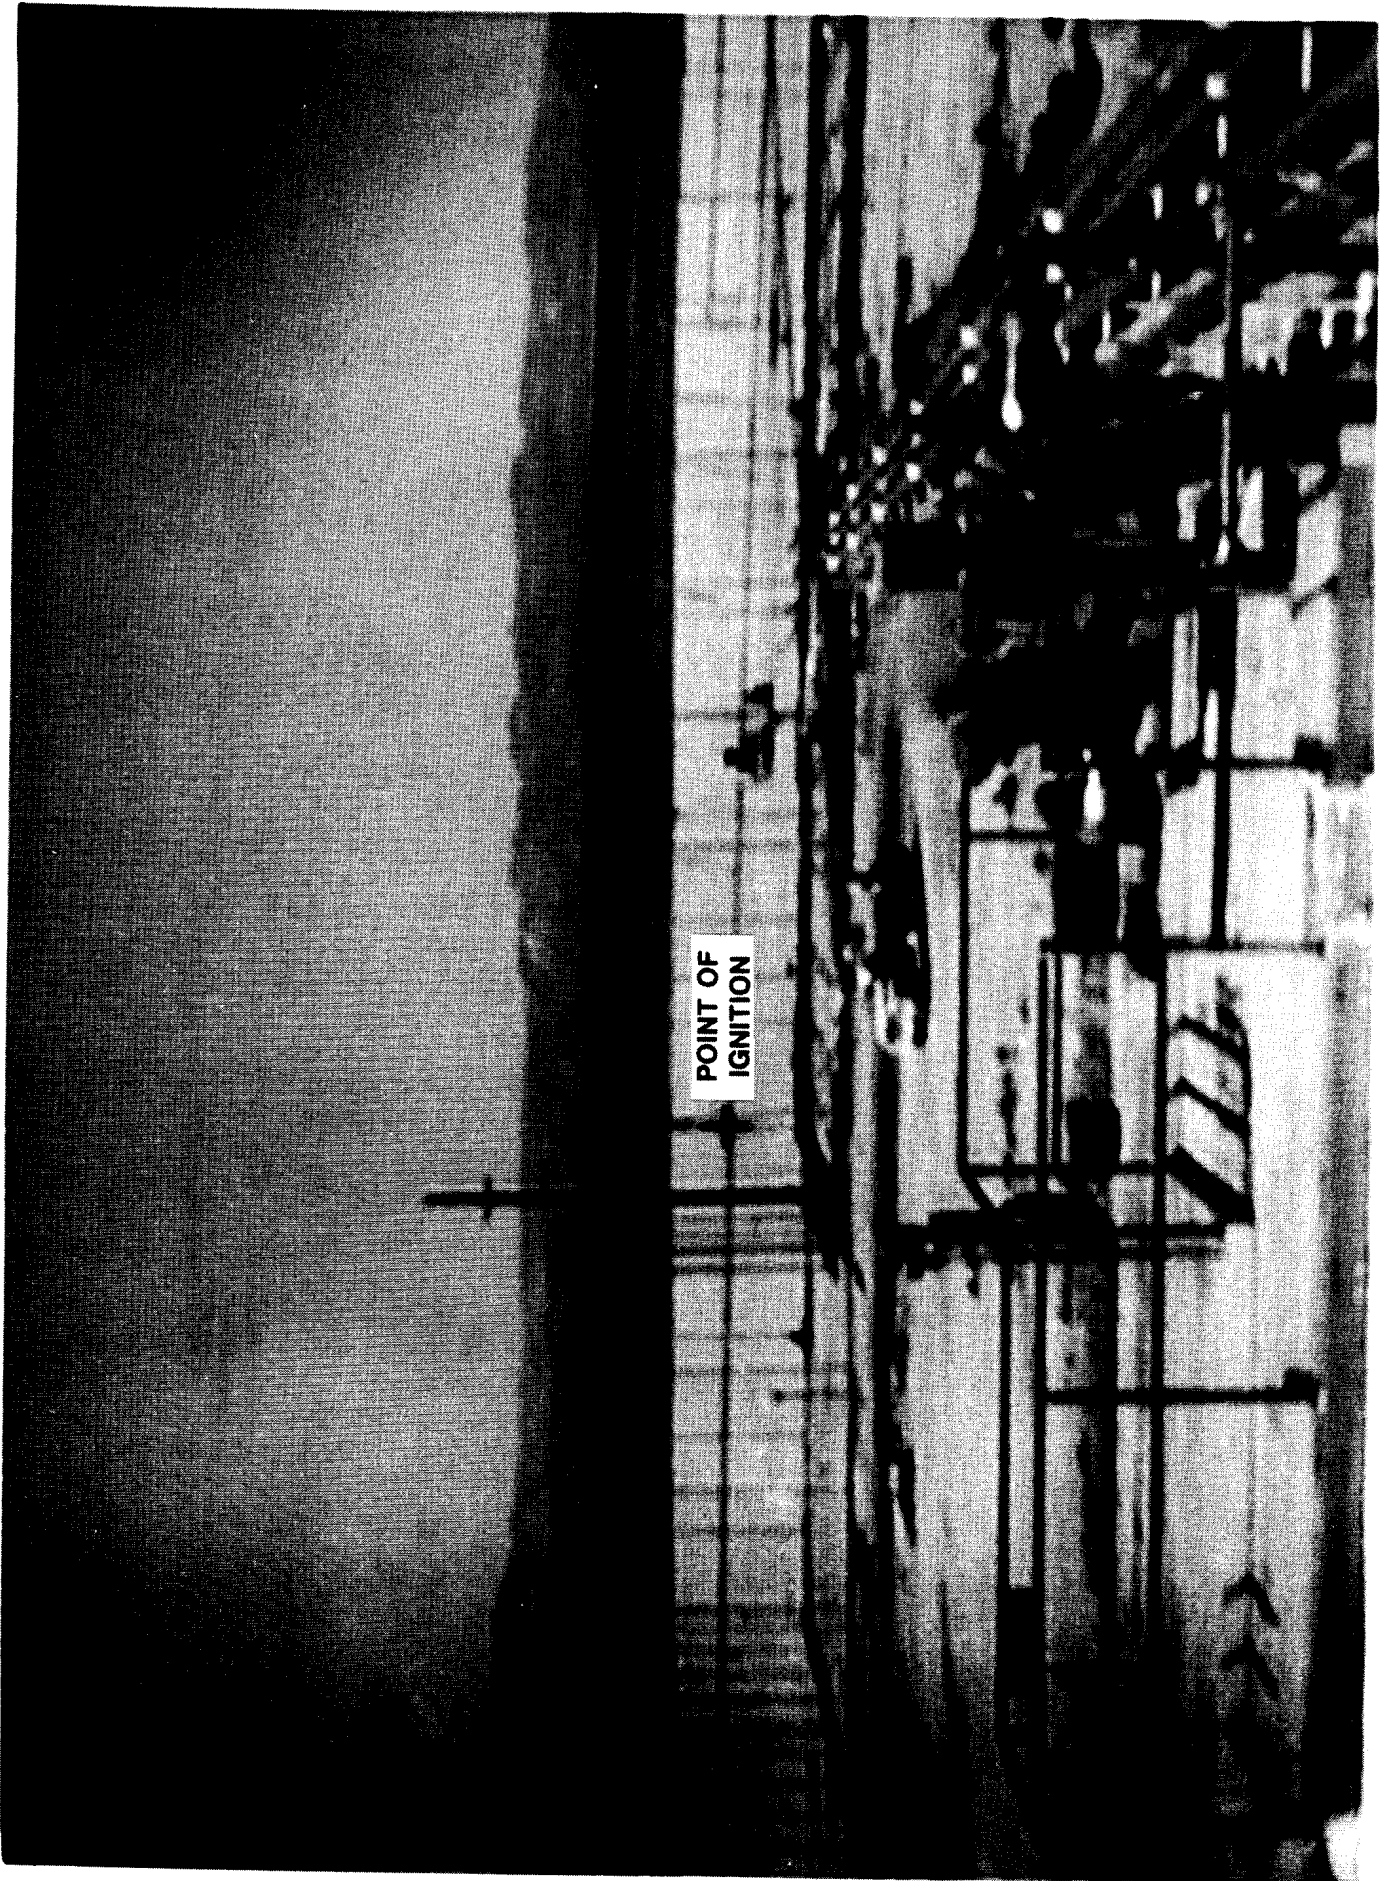
FIGURE 9b

19. The view from video camera 2 appears to show that the ignition of the fire was outside the vapor curtain at about pole 5 and approximately 1/3 the way down from the top of the curtain. The point of ignition can be seen in Figure 9. The concept that the fire started outside the vapor curtain is supported by the fact that pictures from video camera 2, well after ignition, do not show the appearance of a hole in the curtain from light of the fire burning inside the curtain shining through such an opening. Figure 10 shows the curtain at 18:59:30:03. No light can be observed from behind the curtain where the fire is burning, indicating no hole is present.

POINT OF
IGNITION

A consensus was reached that the point of ignition was on the outside of the curtain at the point observed in frame 18:59:21:08 shown on camera 2. The next question was, considering the ignition scenarios proposed, which ones would be capable of igniting the natural gas vapor at pole 5 approximately 1/3 of the way down from the top of the vapor curtain, a distance of 6 meters (20 feet) above the ground.
