**REPORT
of the
INVESTIGATION BOARD
for the
UNPLANNED FIRE
at the
LIQUEFIED GASEOUS FUELS
SPILL TEST FACILITY
on
AUGUST 29, 1987**

REPORT OF THE
INVESTIGATION BOARD FOR
THE UNPLANNED FIRE AT THE
LIQUEFIED GASEOUS FUELS SPILL TEST FACILITY
ON AUGUST 29, 1987

OCTOBER 23, 1987

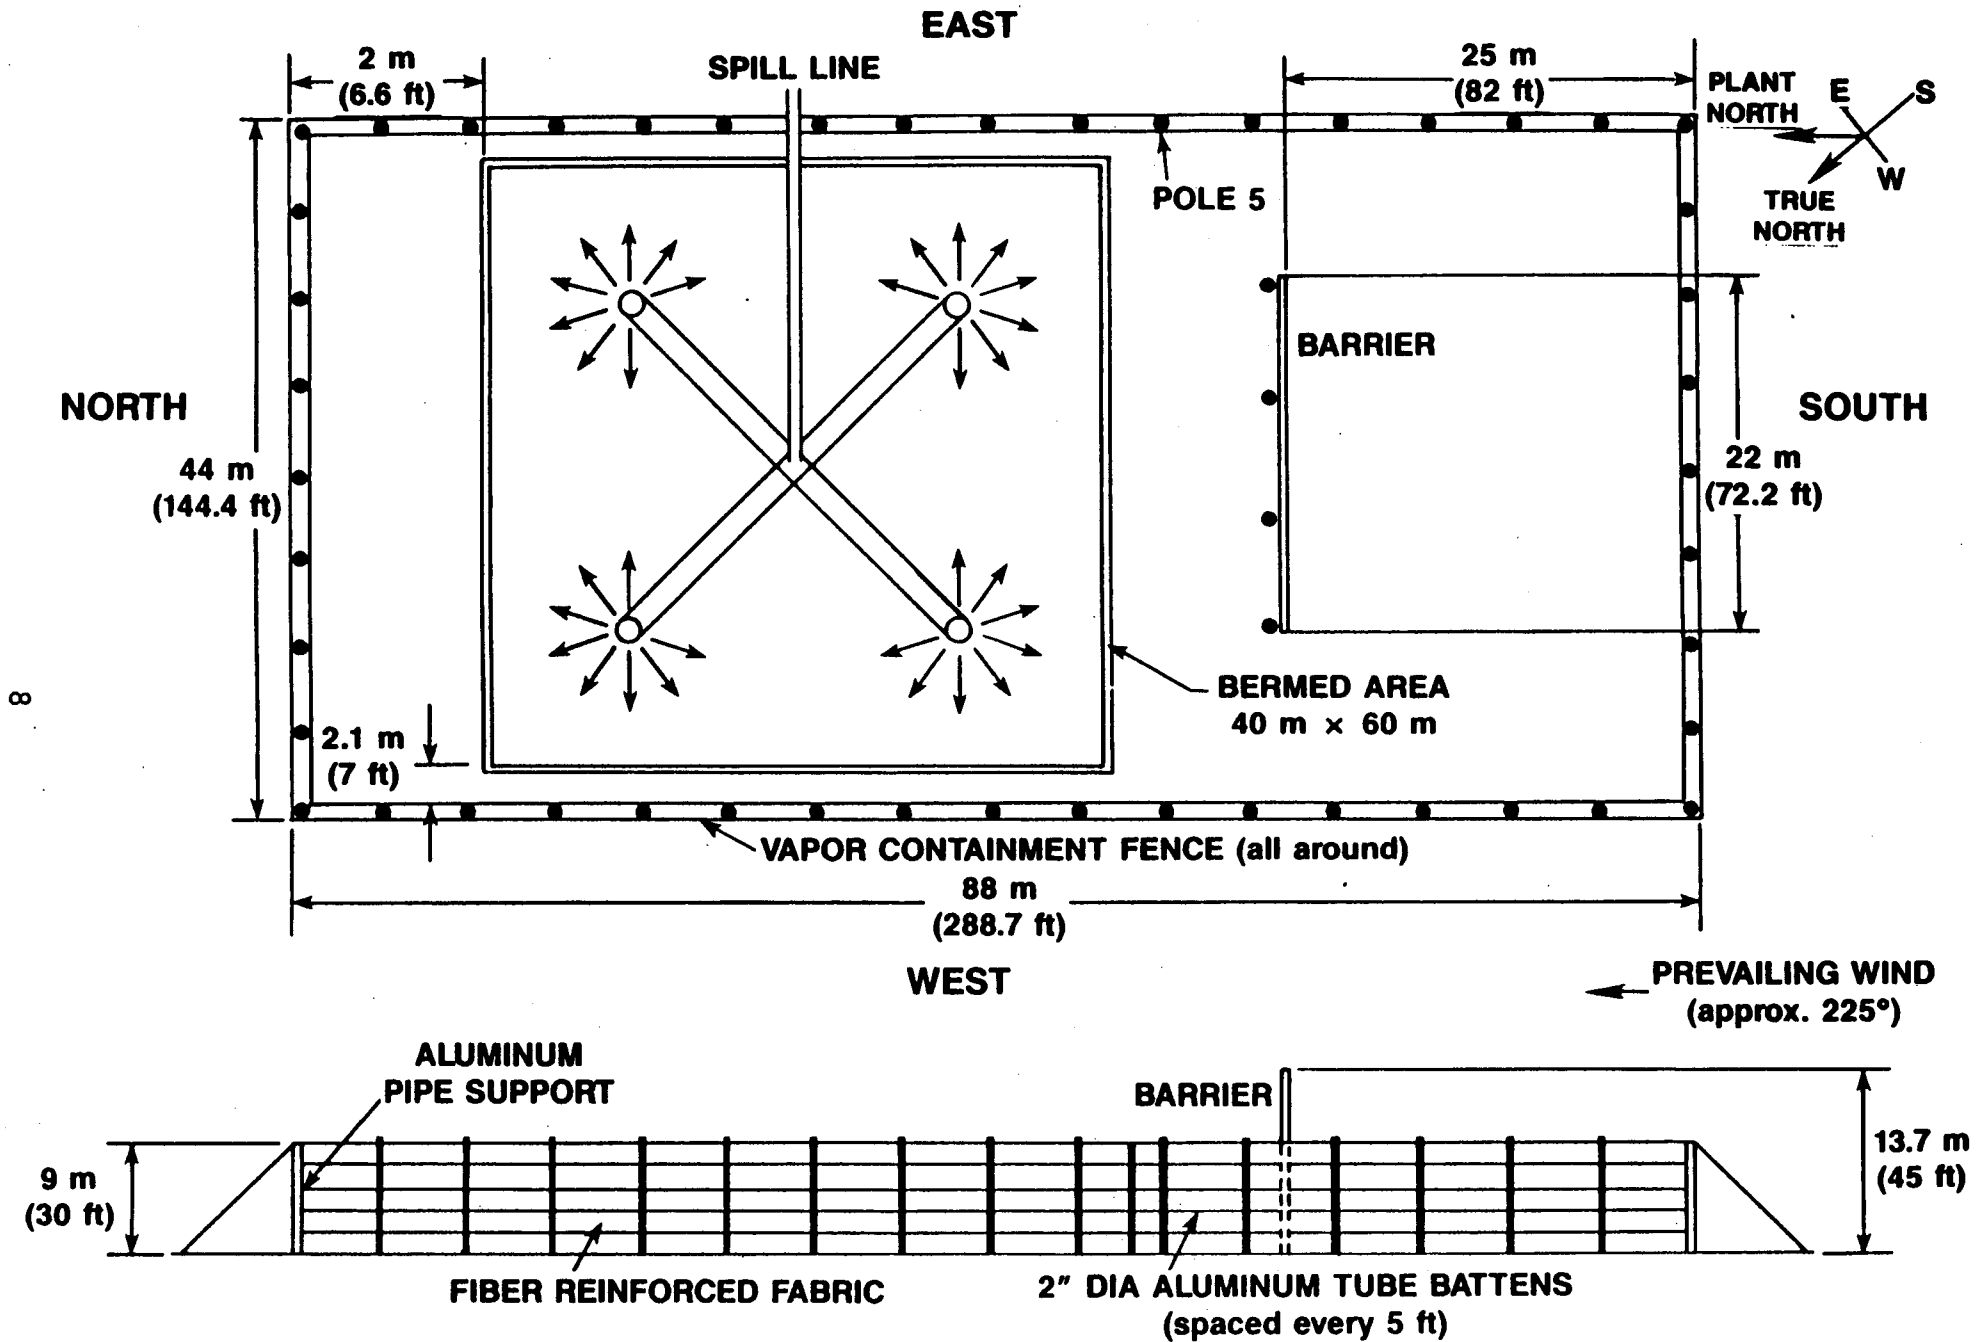
FIGURE 1

The spill test area (see Figure 1) was surrounded by a 8.5-m (28 ft) high fiberglass curtain that was to serve as a vapor barrier for the purpose of decreasing the downwind dispersion of the natural gas vapors. Horizontal battens were emplaced in the curtain for stability.

SCHEMATIC DIAGRAM OF SPILL TEST AREA

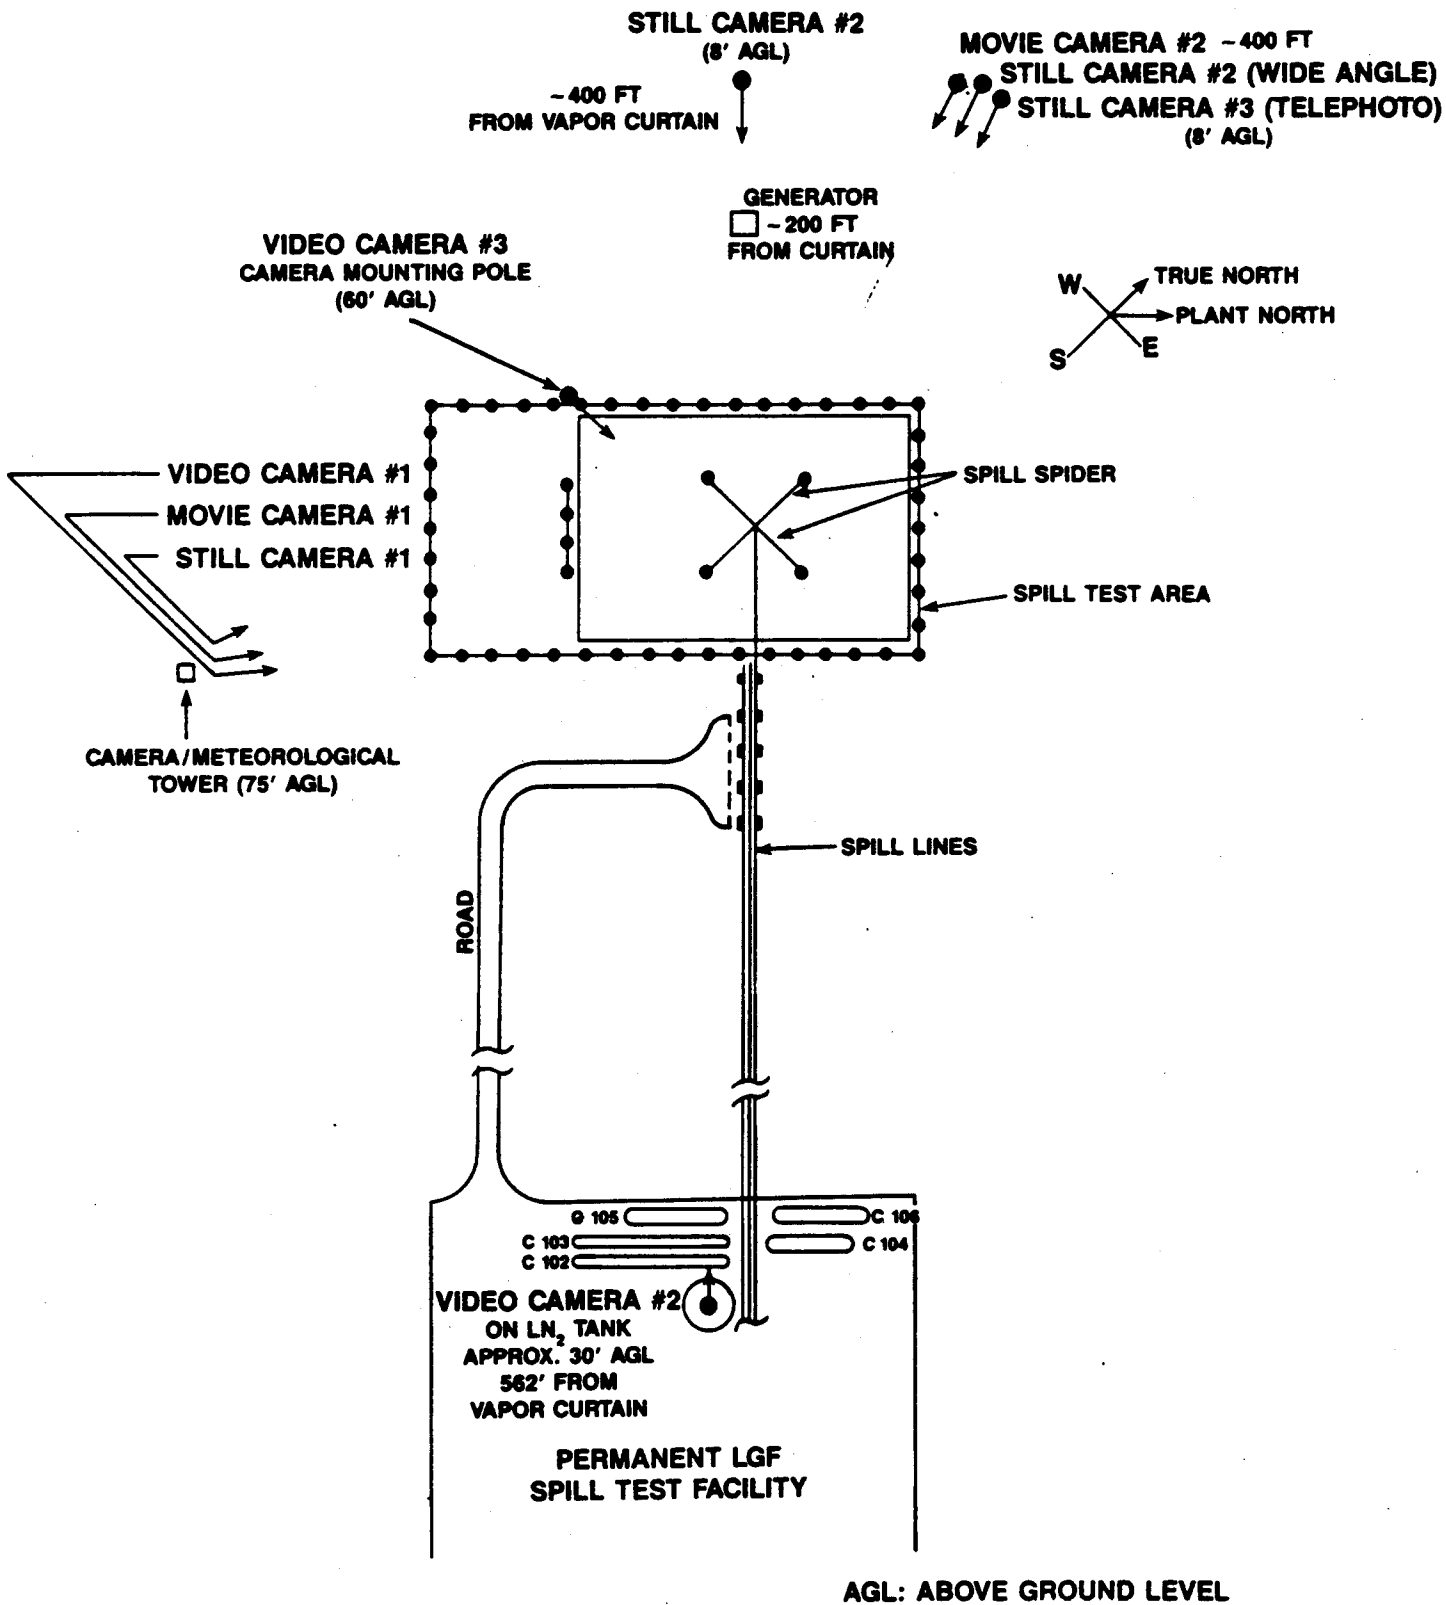
FIGURE 3

1. The entire experiment and fire was extensively recorded. Three video cameras, two movie cameras, and two sets of still cameras were utilized and were located at the positions noted in Figure 3. The videotapes recorded at 30 frames a second, and the movie cameras recorded at 24 frames a second. The still cameras were programmed at a frame rate that varied from a frame every 6 seconds to a frame every 30 seconds. The video system used a common time signal that was fed to the video channels and recorded on all three tapes. The record of time on the video is as follows: 18:59:21:08. The first number is the hour, the second the minute, the third are seconds, and the fourth is the frame number (frame numbers vary from 01 to 30). The movie cameras were keyed to a time signal from station WWV (the radio station operated by the National Bureau of Standards). There was no measured relationship between the two time signals.

SCHEMATIC DIAGRAM OF LIQUEFIED GASEOUS FUELS SPILL TEST FACILITY

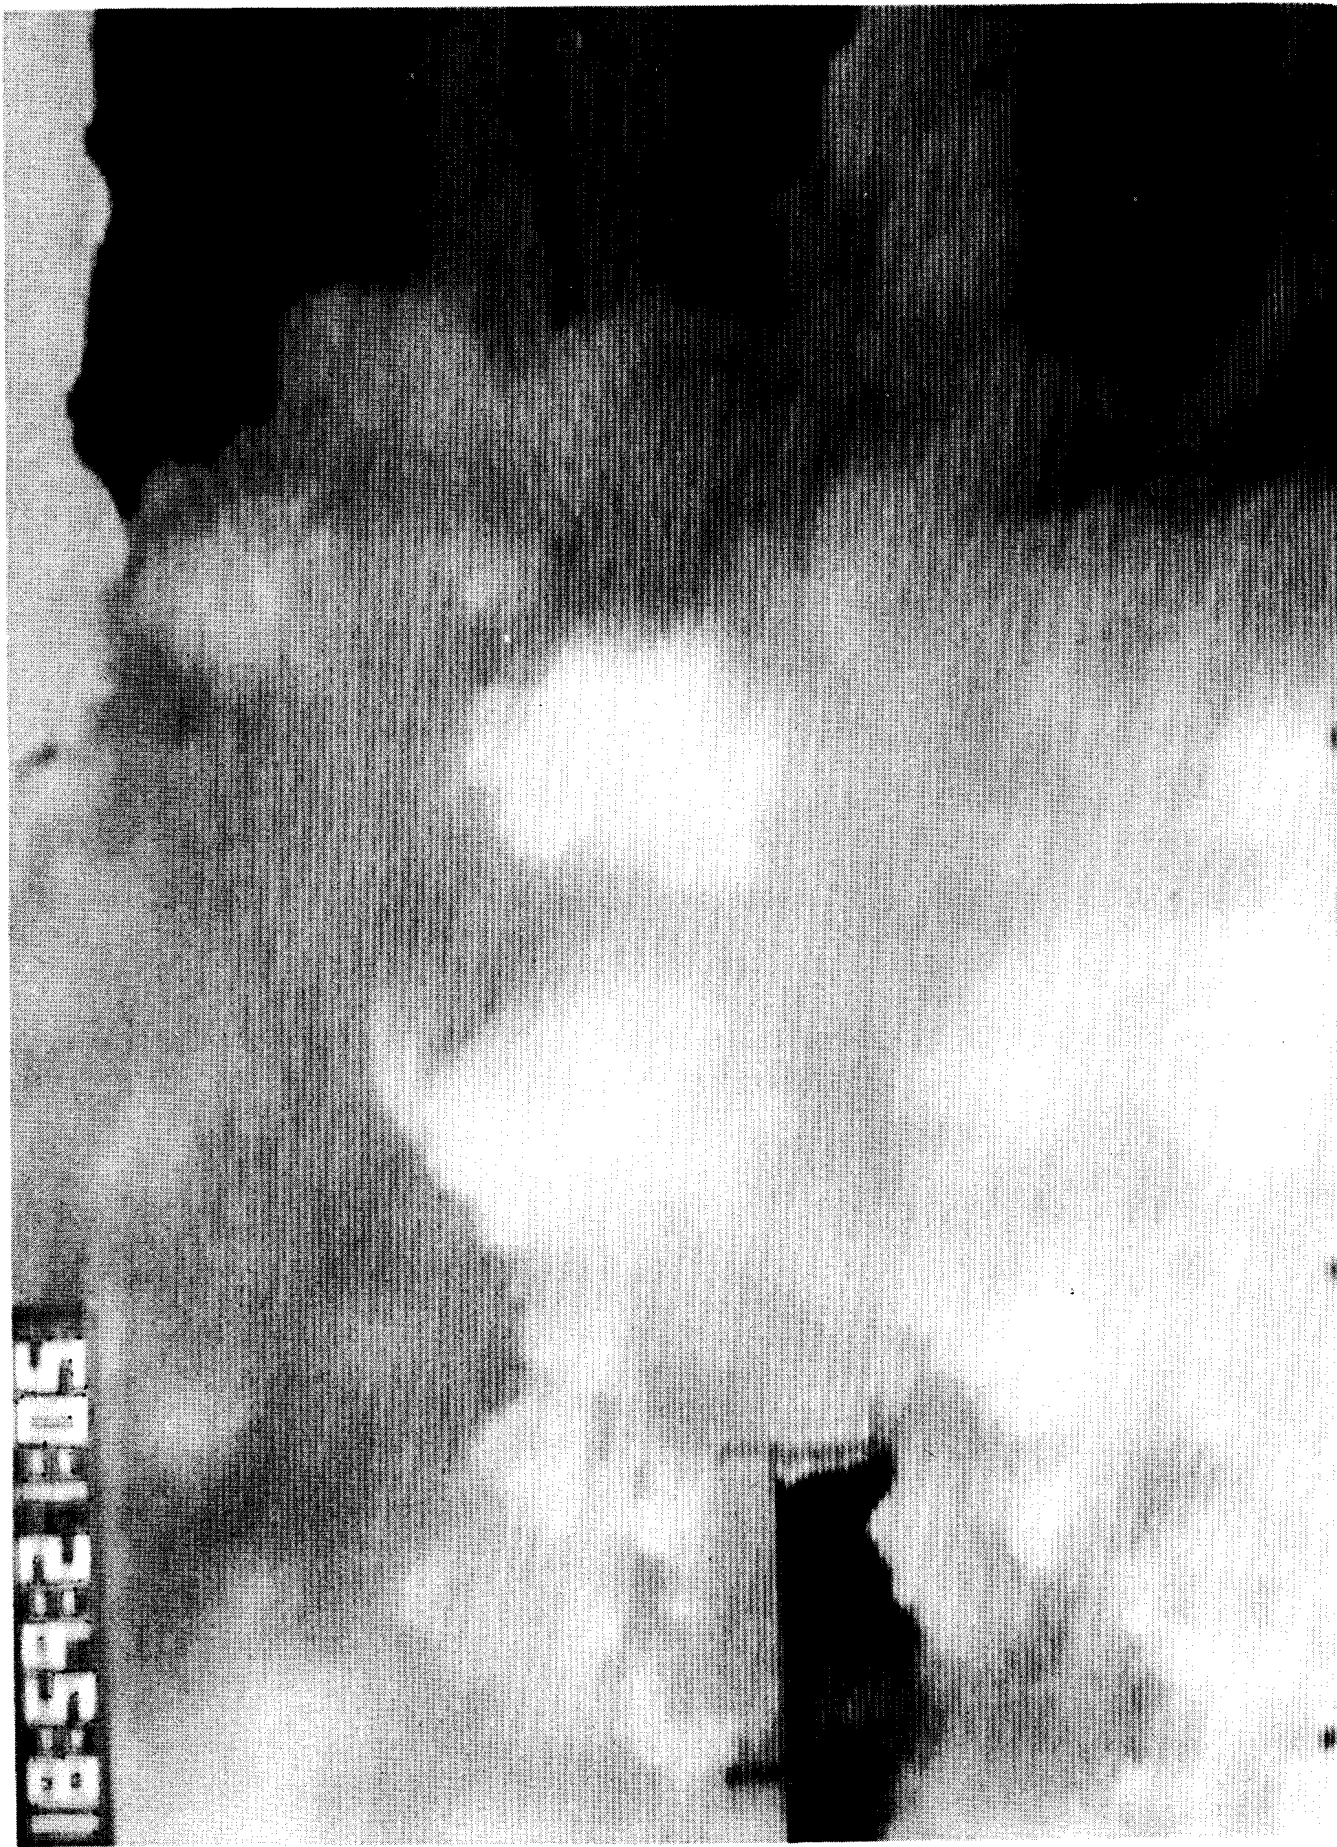
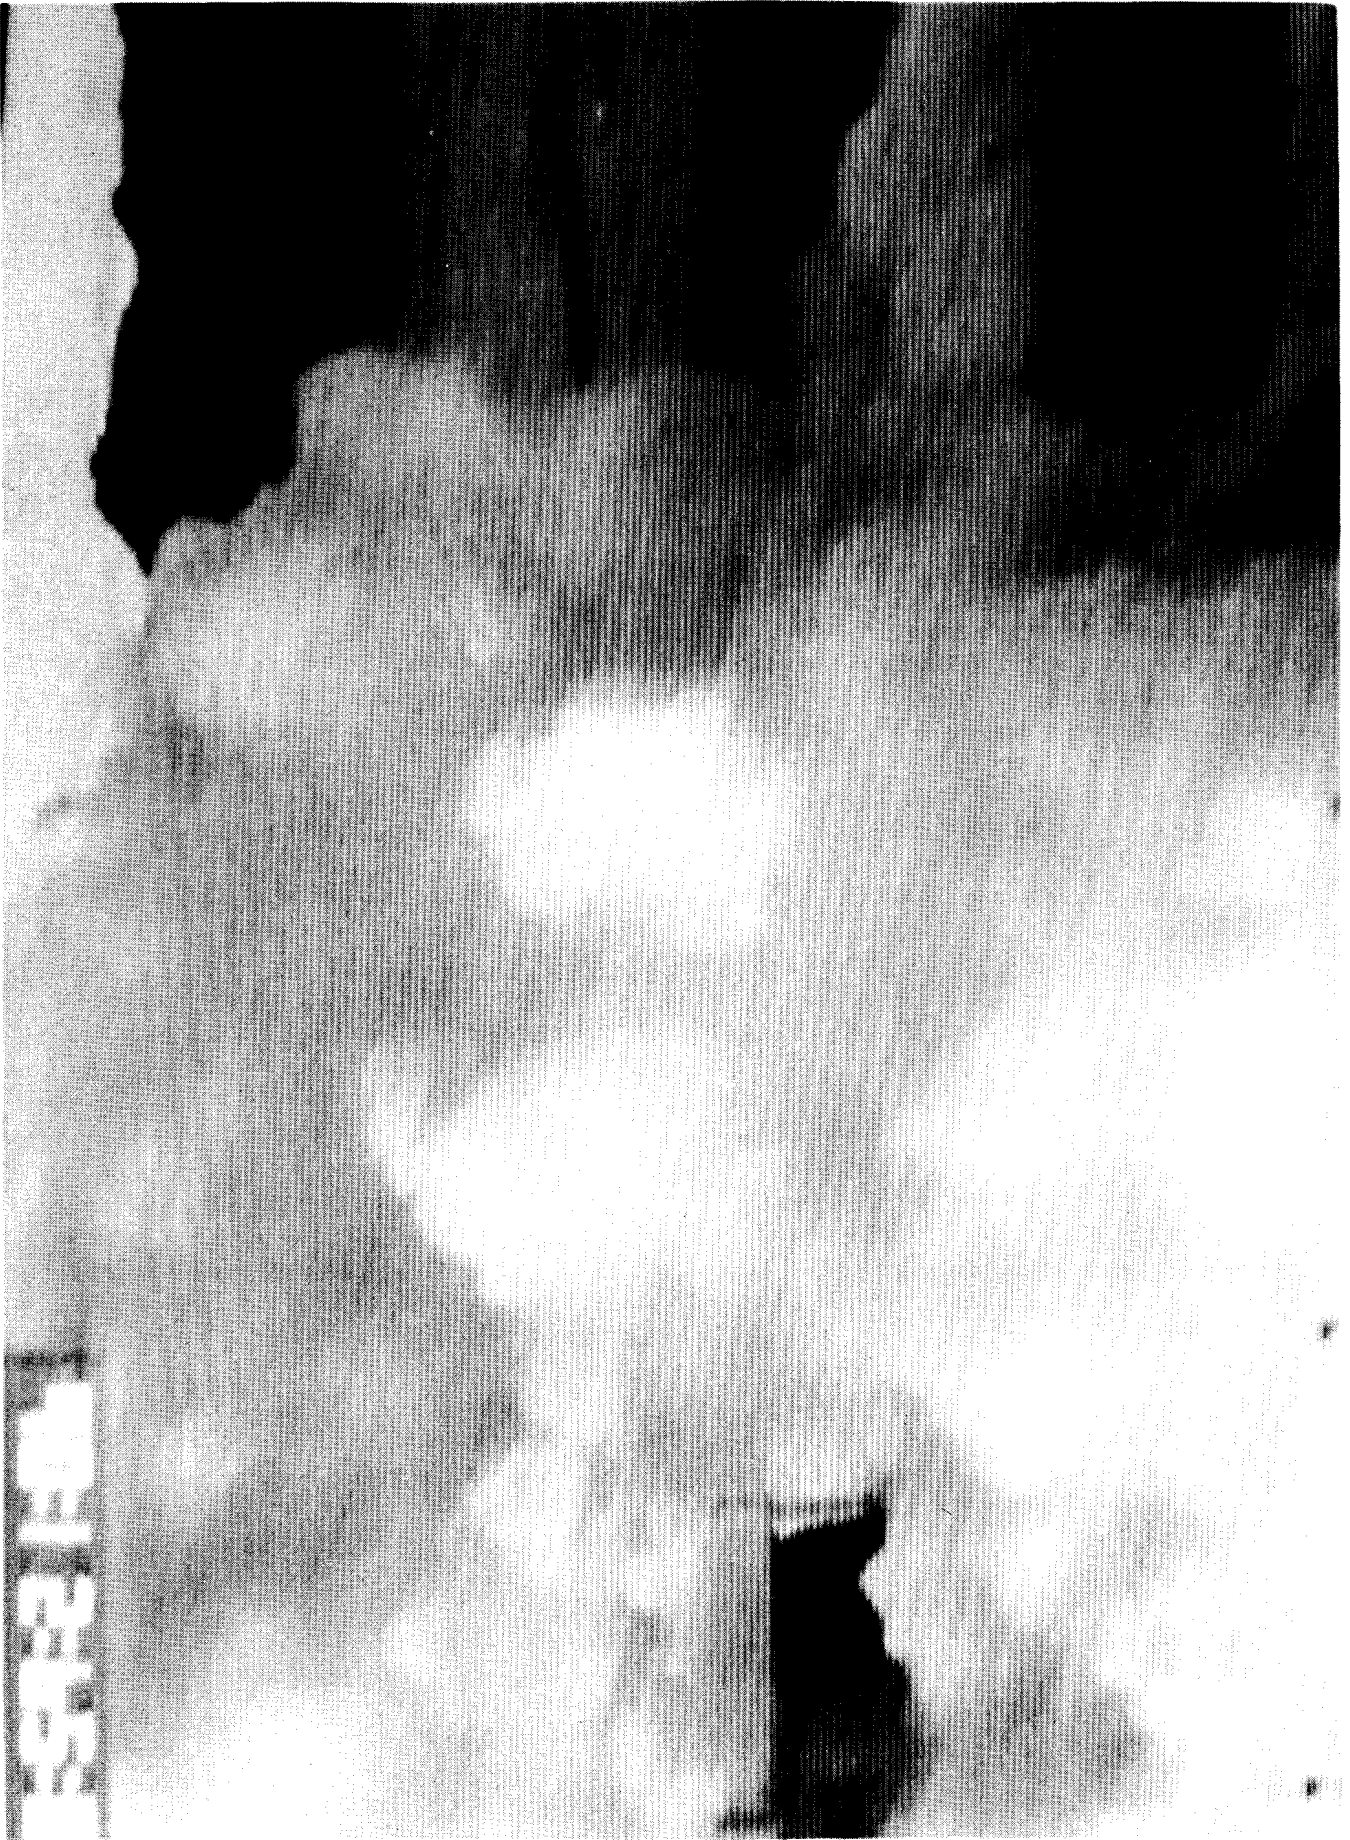
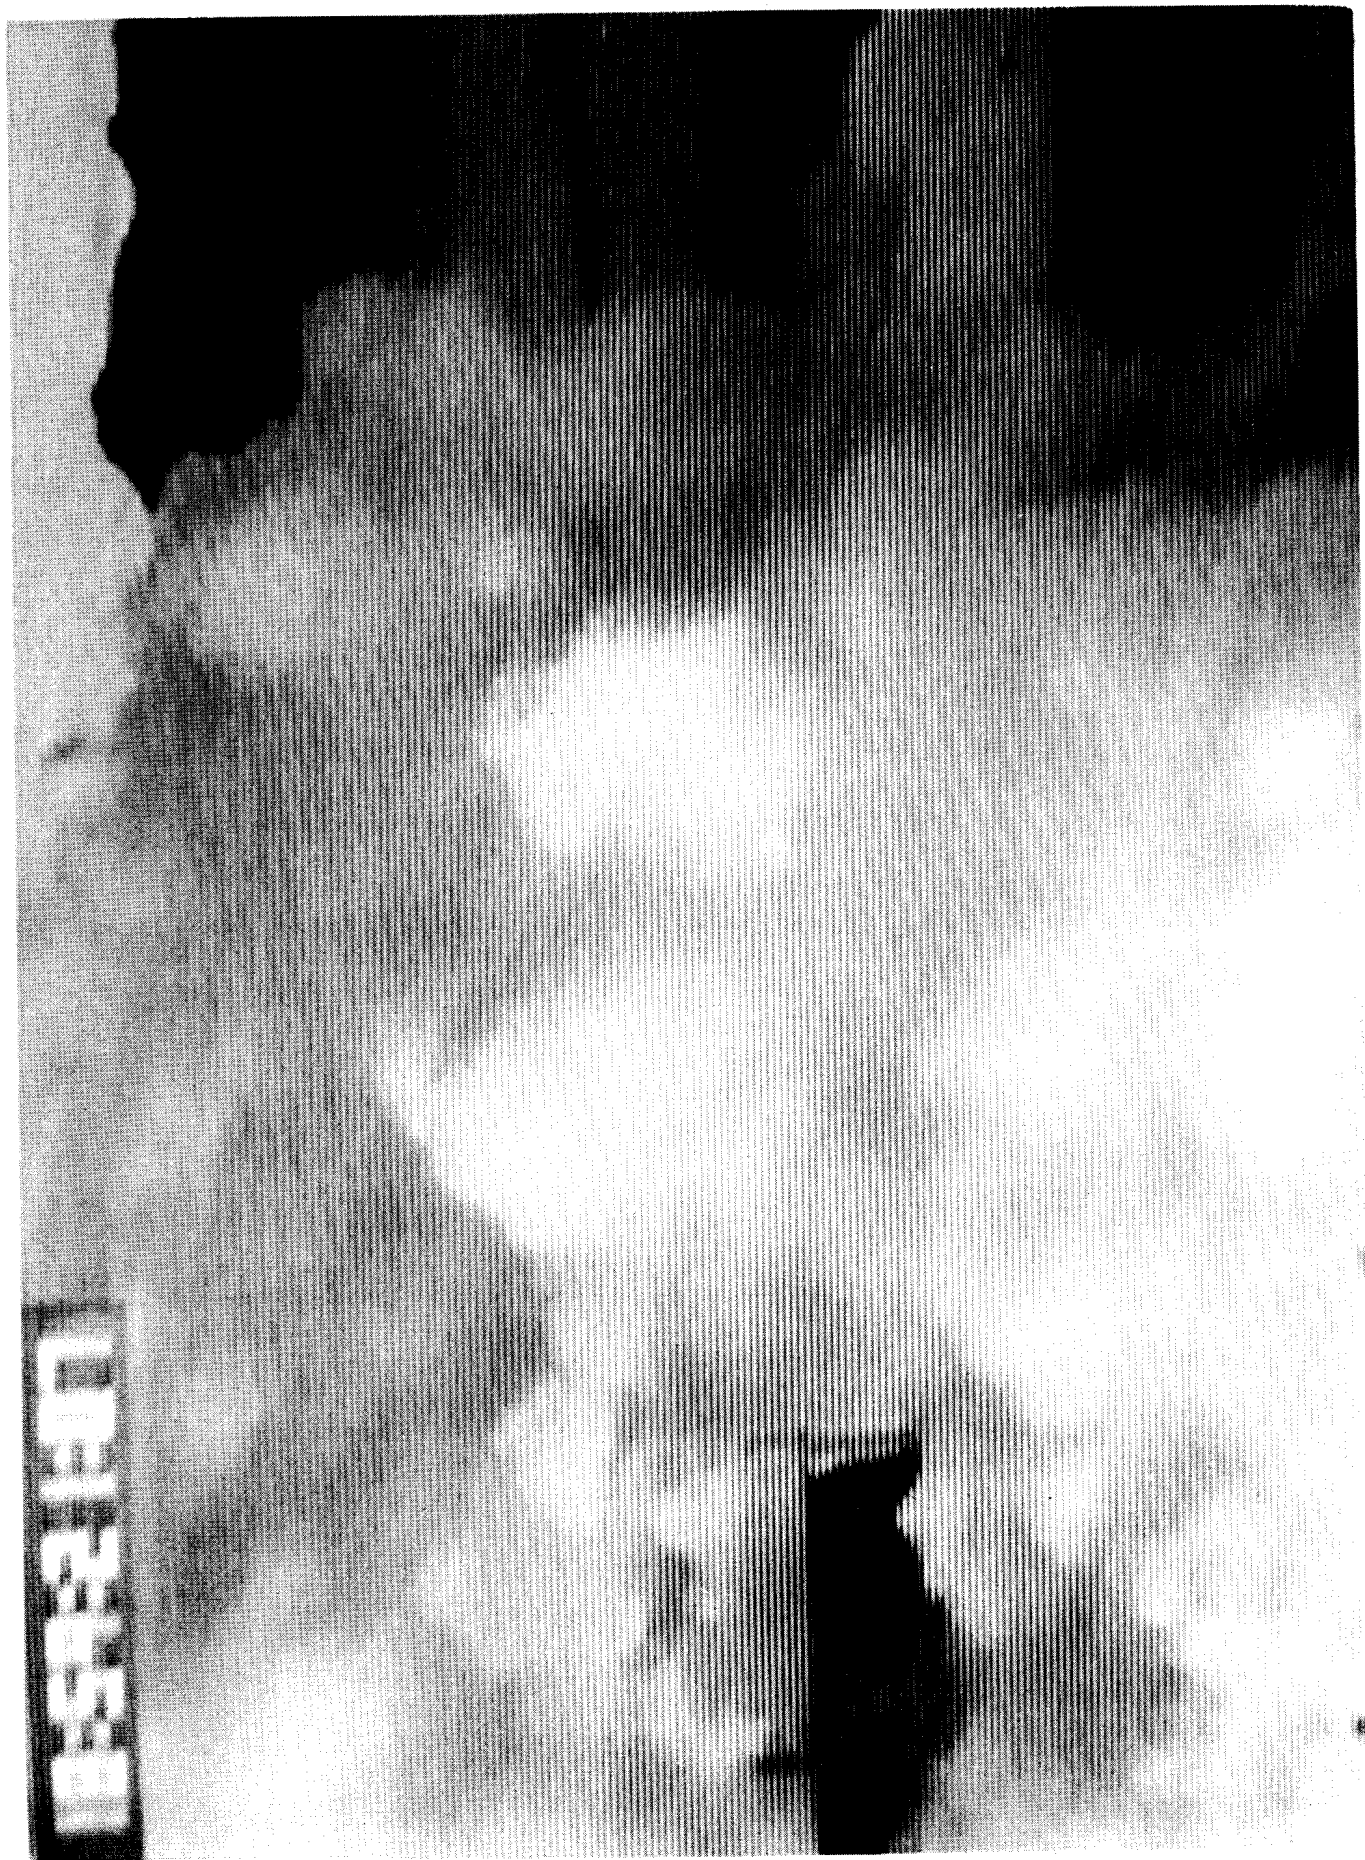
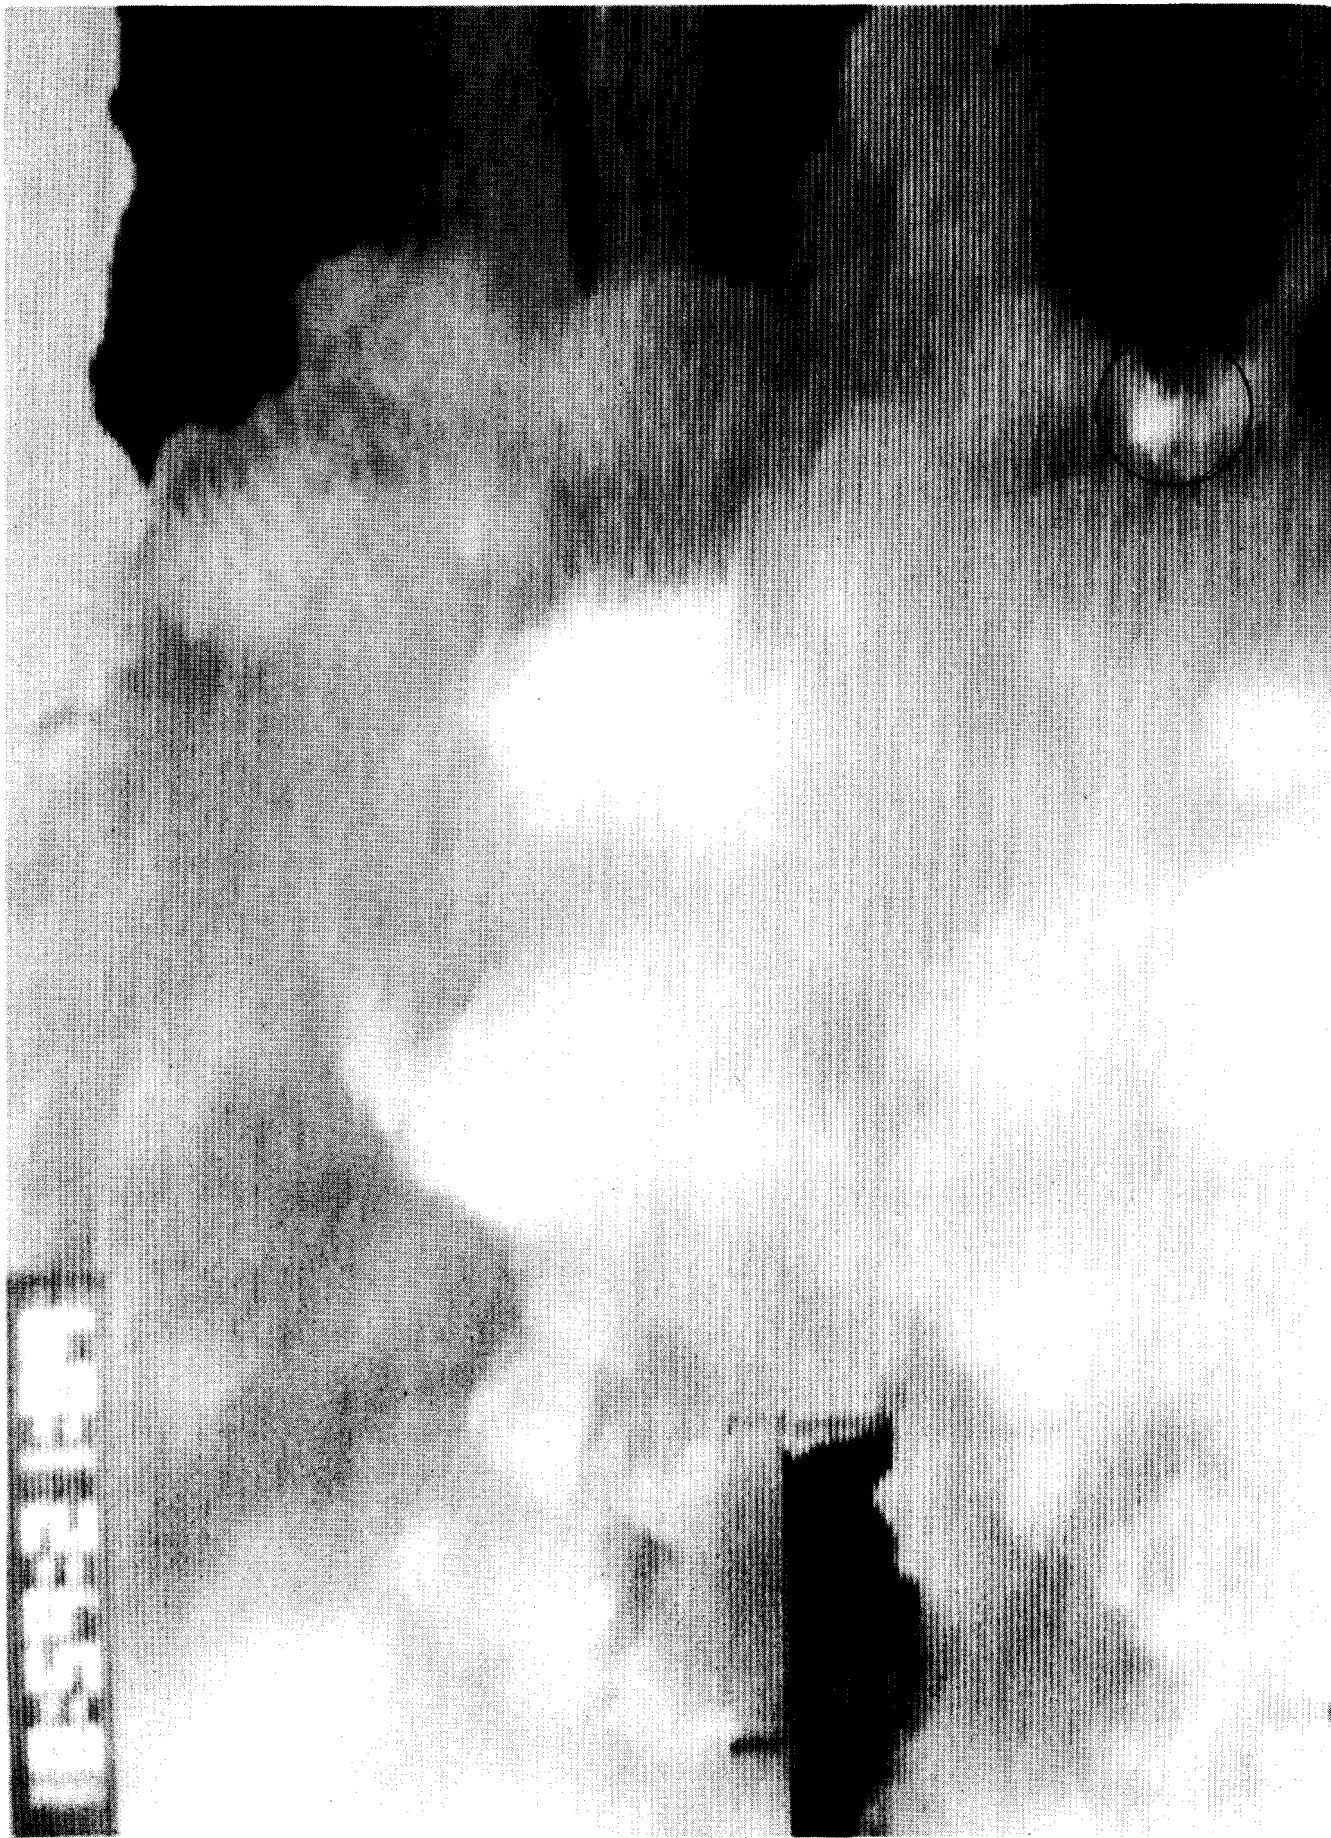
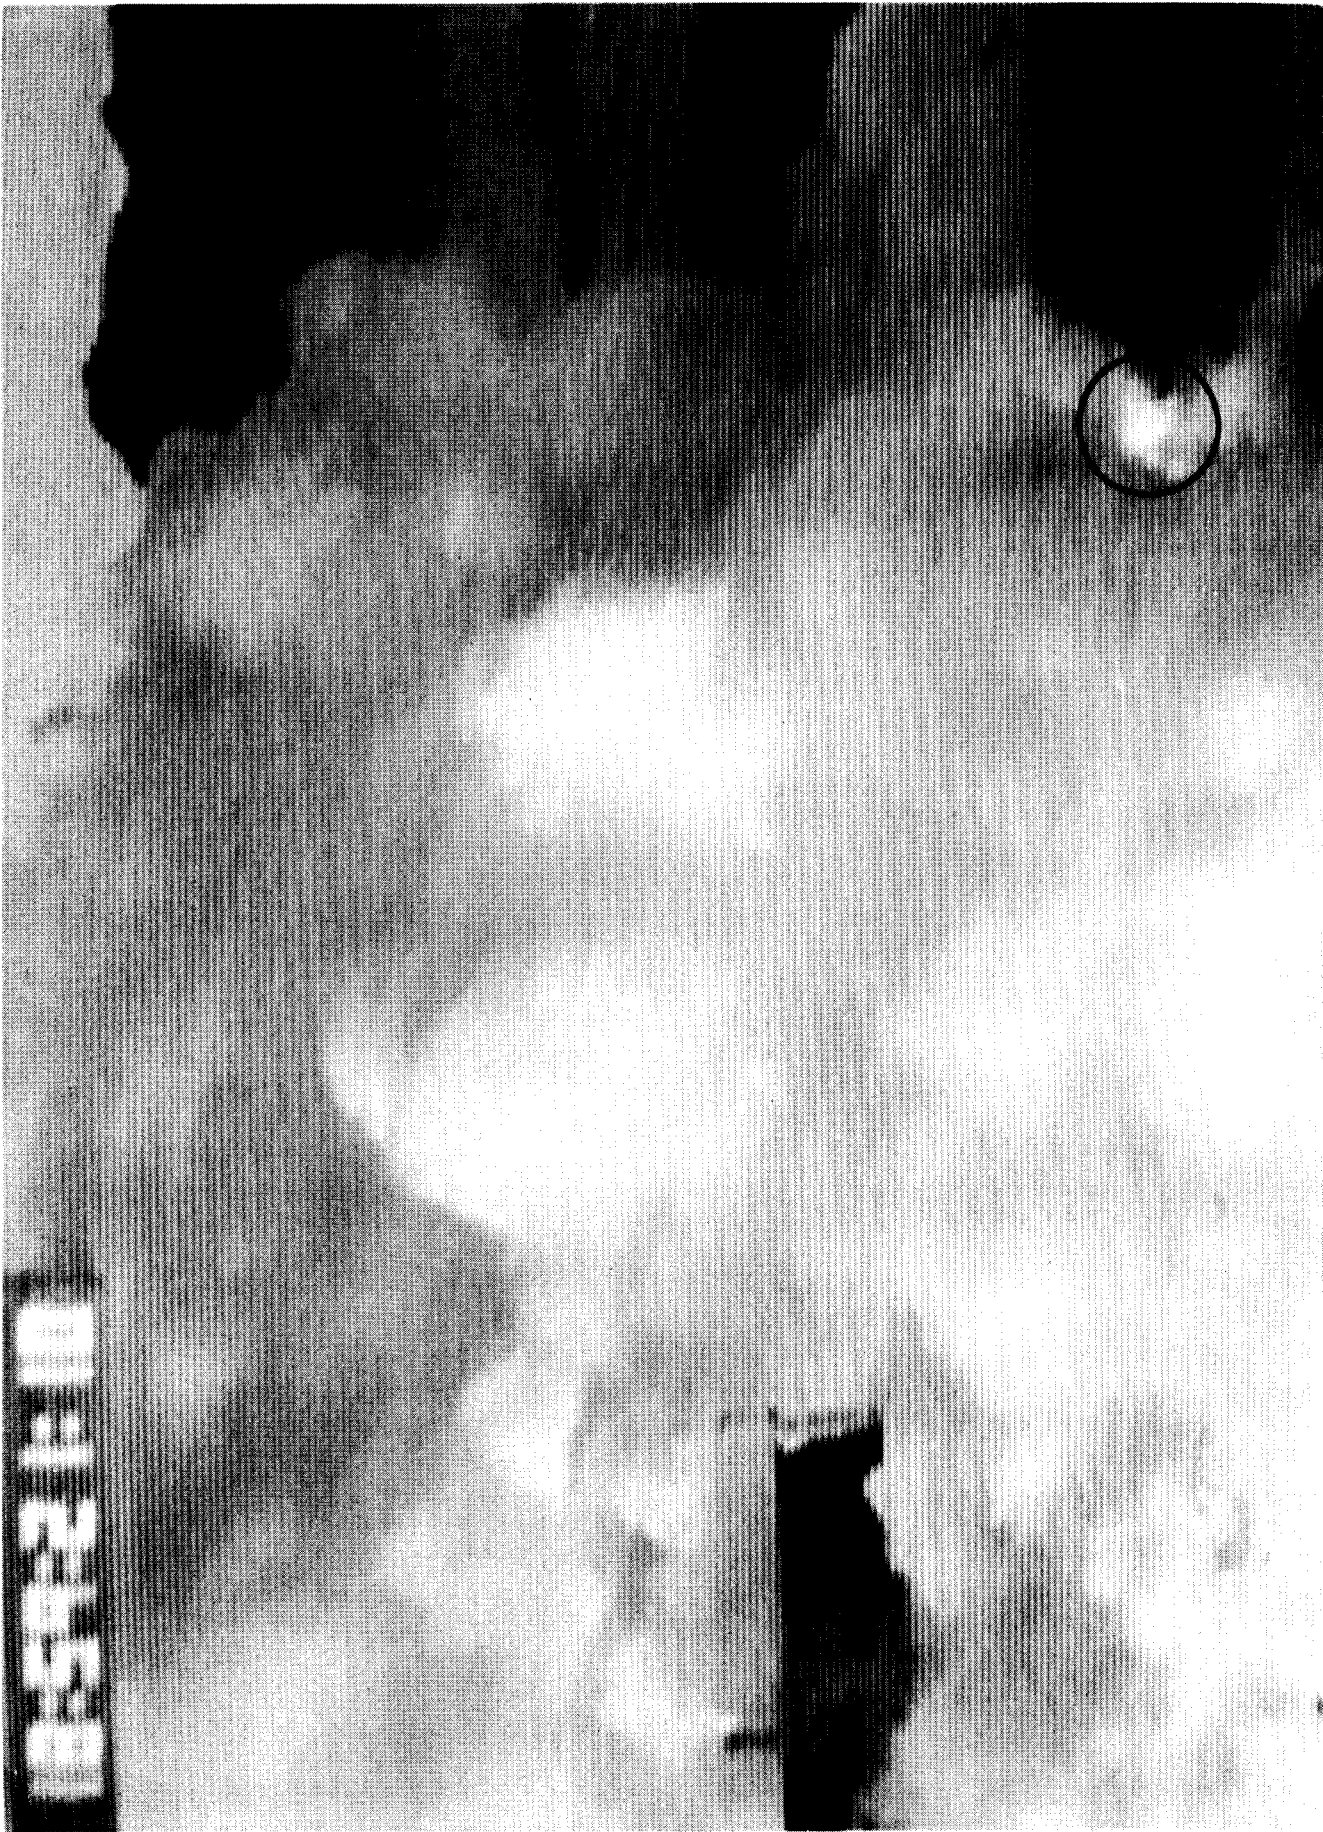
9. Ignition appears to have occurred at 18:59:21:08 (based on images from video camera 2) or 1 minute, 16 seconds into test. Figures 4a through 4s show the sequence of photos taken by the three video cameras and movie camera 1 from just before ignition to just after ignition.

**SPILL TEST AREA: VIDEO CAMERA 1
3/30 OF SECOND BEFORE IGNITION**

**SPILL TEST AREA: VIDEO CAMERA 1
2/30 OF SECOND BEFORE IGNITION**

**SPELL TEST AREA: VIDEO CAMERA 1
1/30 OF SECOND BEFORE IGNITION**
FIGURE 4c

**SPELL TEST AREA: VIDEO CAMERA 1
AT IGNITION**
FIGURE 4d

**SPILL TEST AREA: VIDEO CAMERA 1
1/30 OF SECOND AFTER IGNITION**

**SPILL TEST AREA: VIDEO CAMERA 1
2/30 OF SECOND AFTER IGNITION**

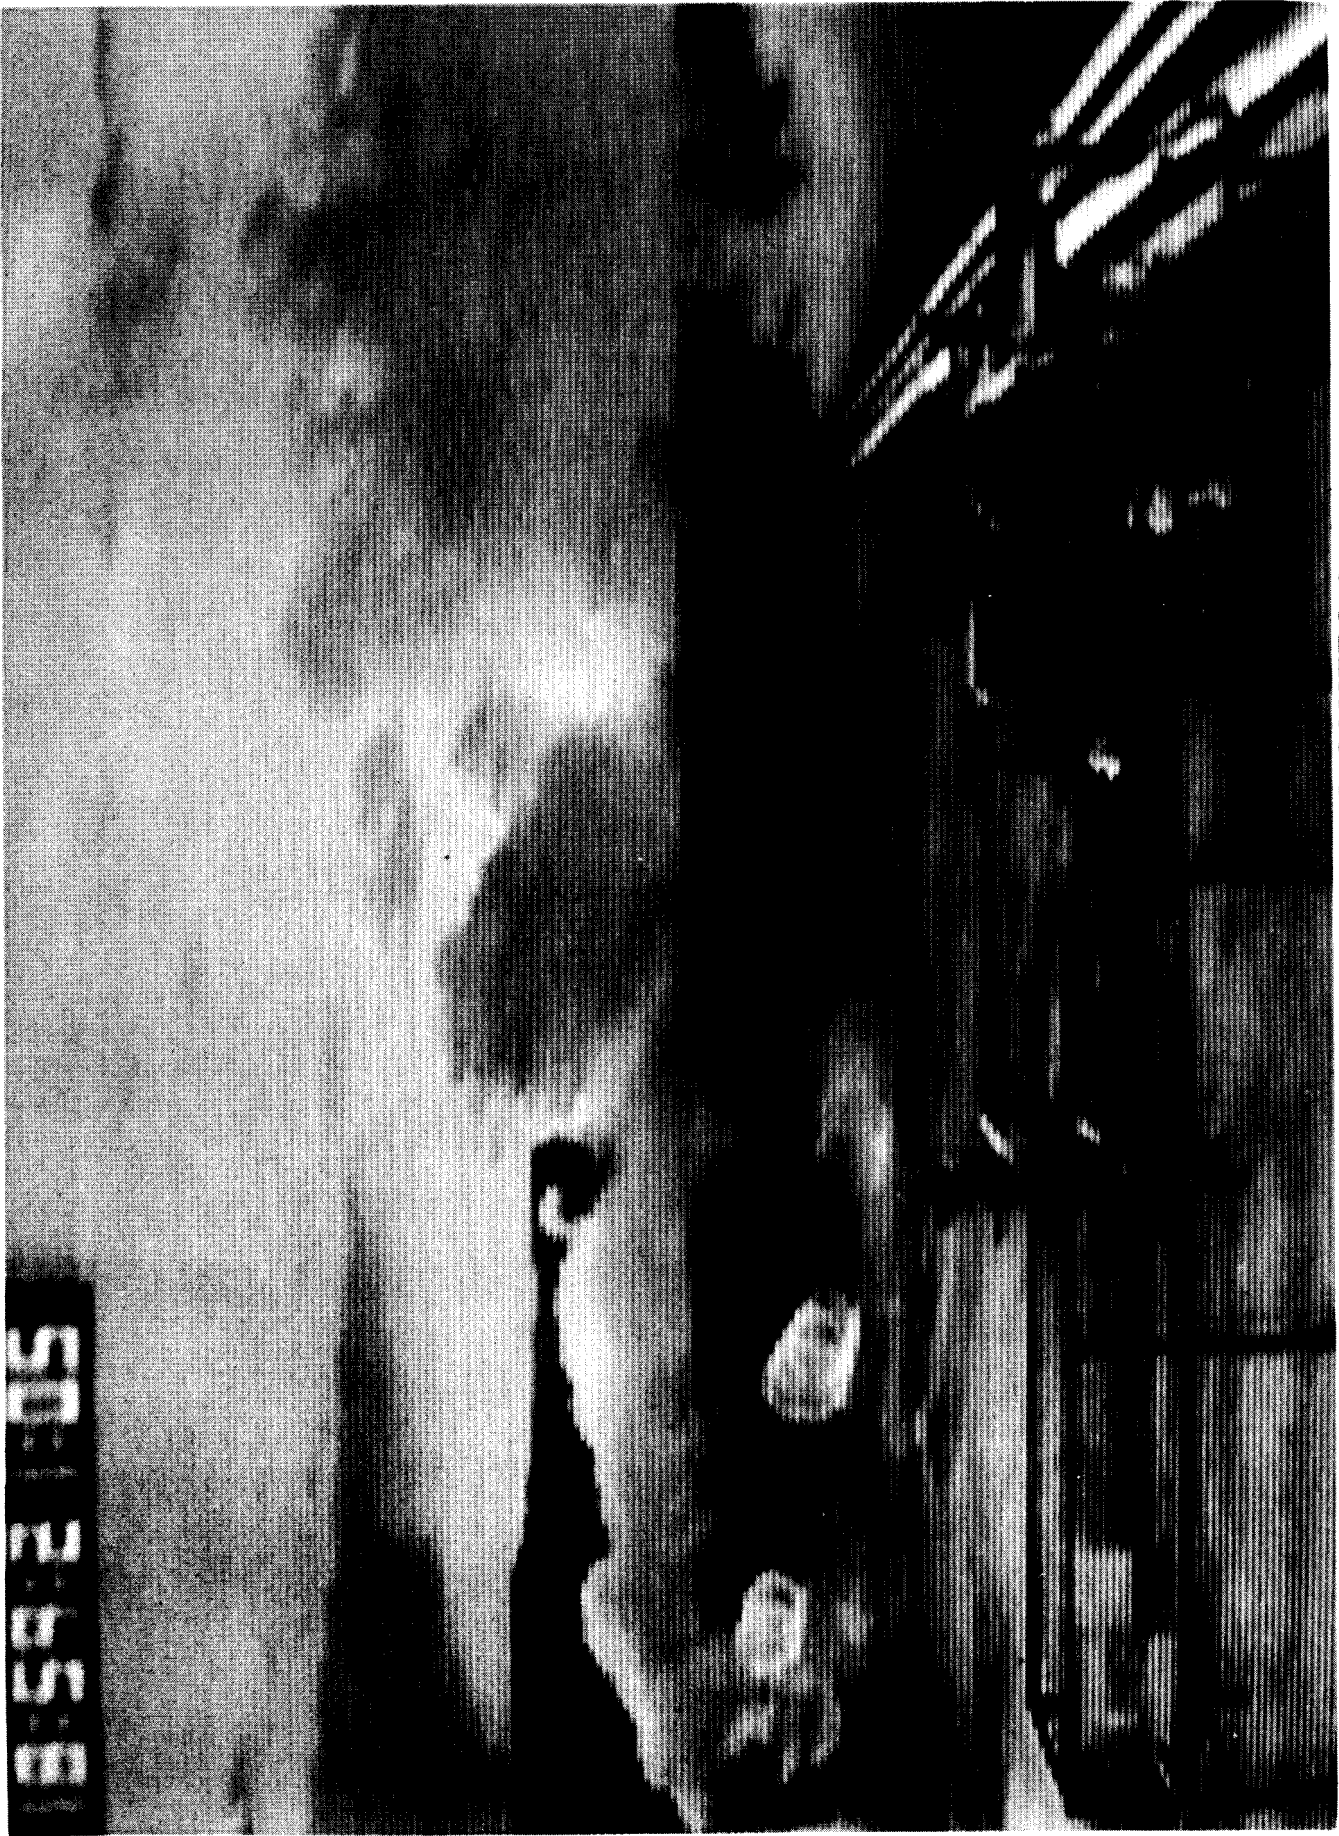
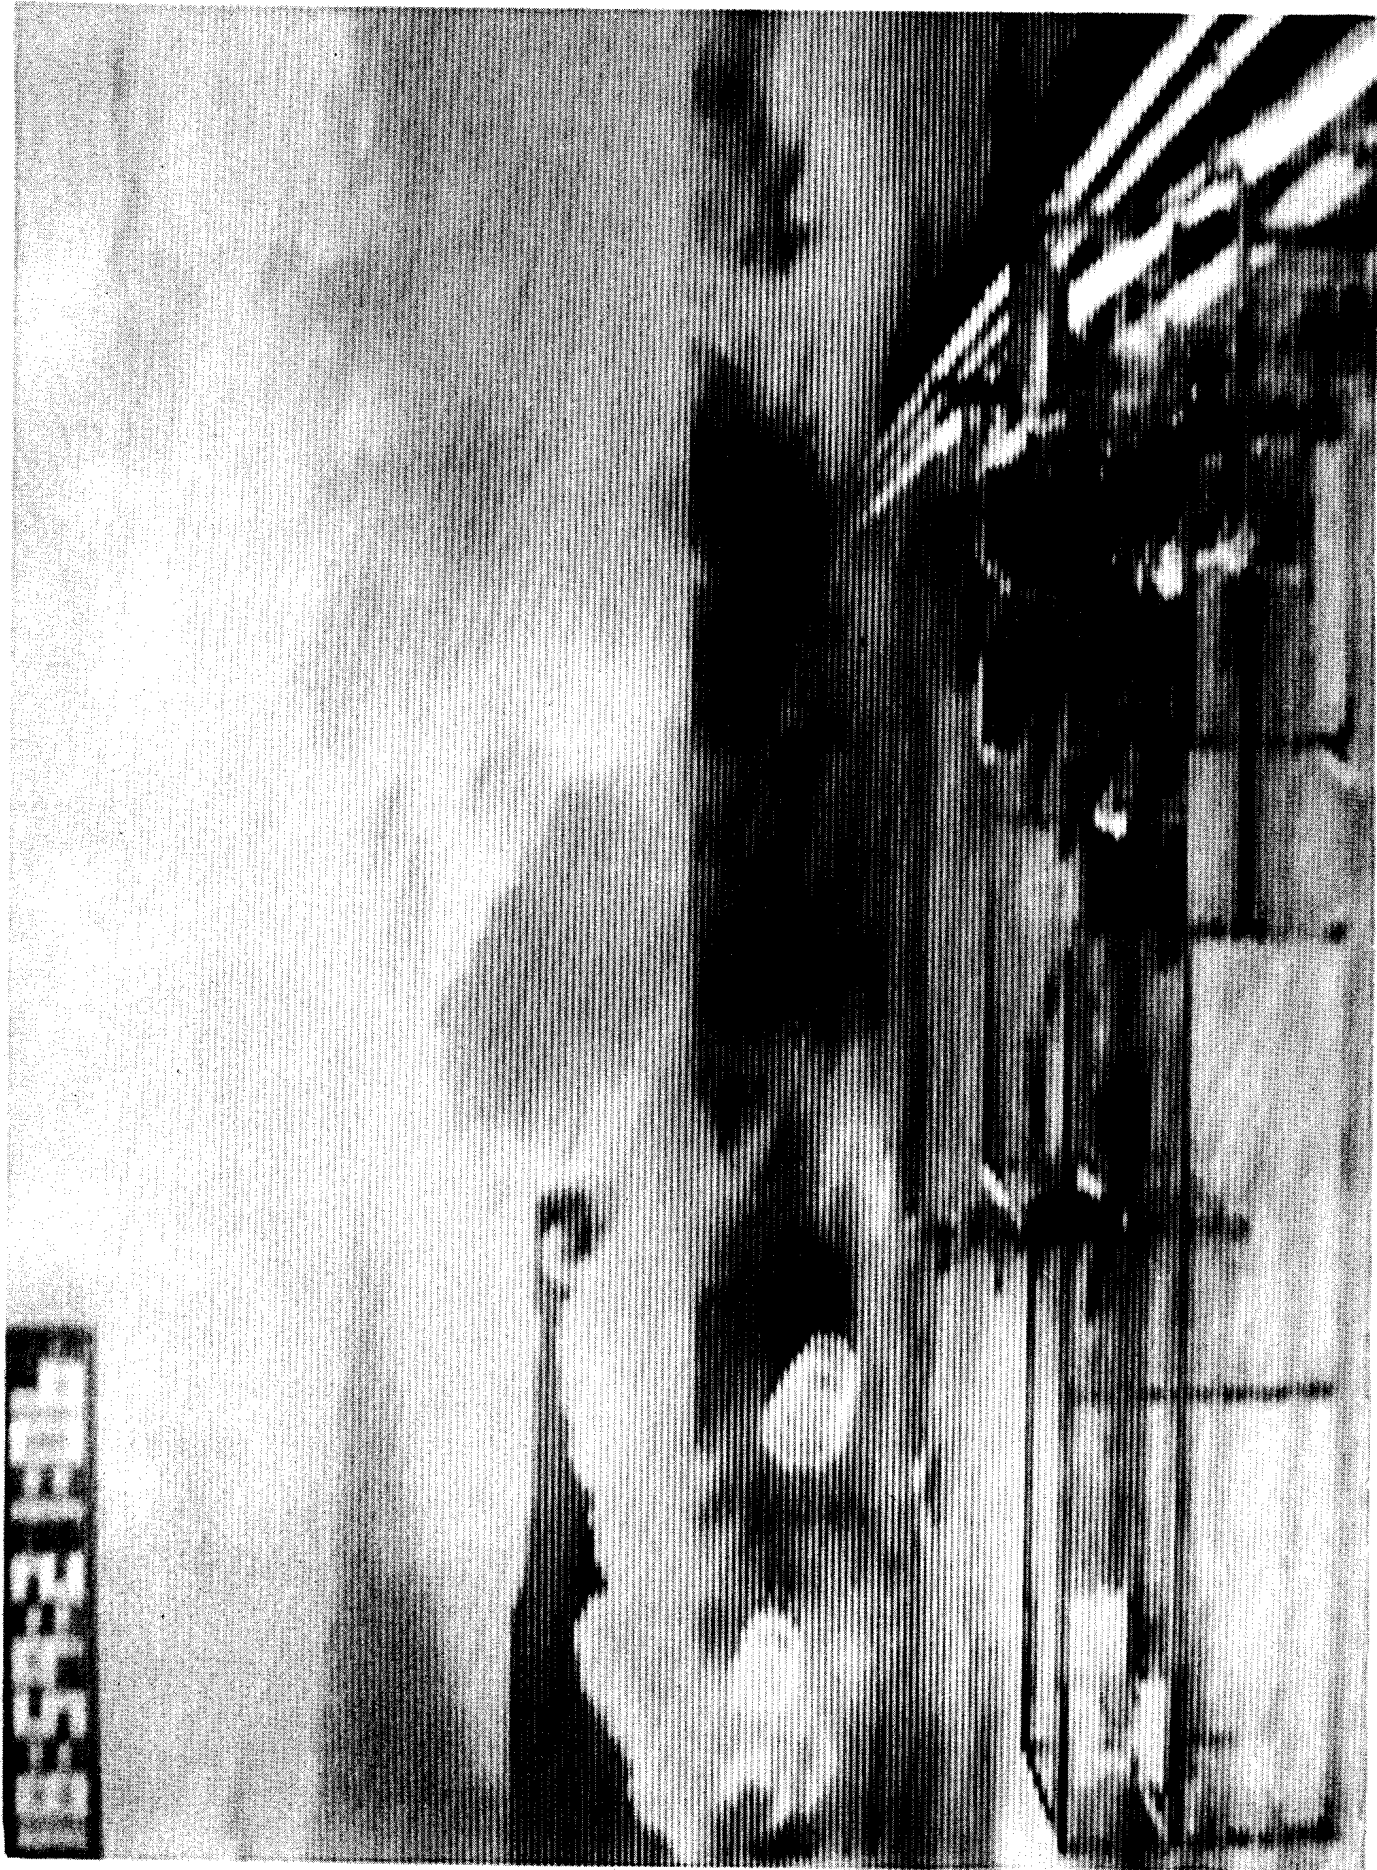
**SPILL TEST AREA: VIDEO CAMERA 2
3/30 OF SECOND BEFORE IGNITION**

**SPILL TEST AREA: VIDEO CAMERA 2
2/30 OF SECOND BEFORE IGNITION**

**SPILL TEST AREA: VIDEO CAMERA 2
1/30 OF SECOND BEFORE IGNITION**

**SPILL TEST AREA: VIDEO CAMERA 2
1/30 OF SECOND AFTER IGNITION**

**SPILL TEST AREA: VIDEO CAMERA 2
2/30 OF SECOND AFTER IGNITION**
