**Risk Assessment of  
Marine Operations  
at  
LNG Terminal  
for  
Shannon Estuary**

**Prepared for : Shannon Foynes Port Company**  
**Report Number : 08-635**  
**Issue : Issue 1**

**Operational Risk Assessment  
Marine Operations at Shannon LNG Terminal**

**June 2008**

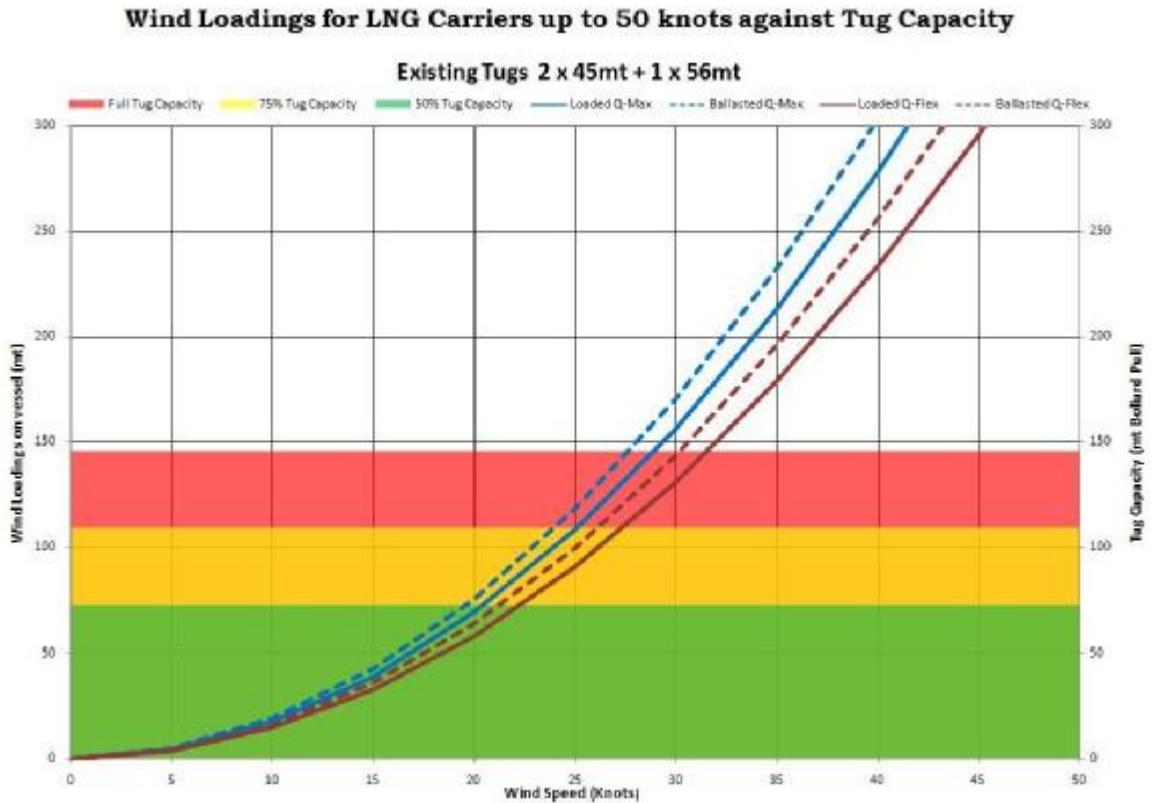
**Diagram 1: Baseline Case: Existing Tug Fleet**

**Wind Loadings for LNG Carriers up to 50 knots against Tug Capacity**

The capacity of the new tug fleet (proposed is approx 280mt) would be able to handle a Q-Flex up to 30 knots and gusts of 35 knots; winds for a Q-Max is slightly lower. Thus a mean wind speed of 25 knots would be an appropriate guideline, and 30 knots if the wind was steady and in a favourable direction. It can also be seen that if one tug was out of service then operations should

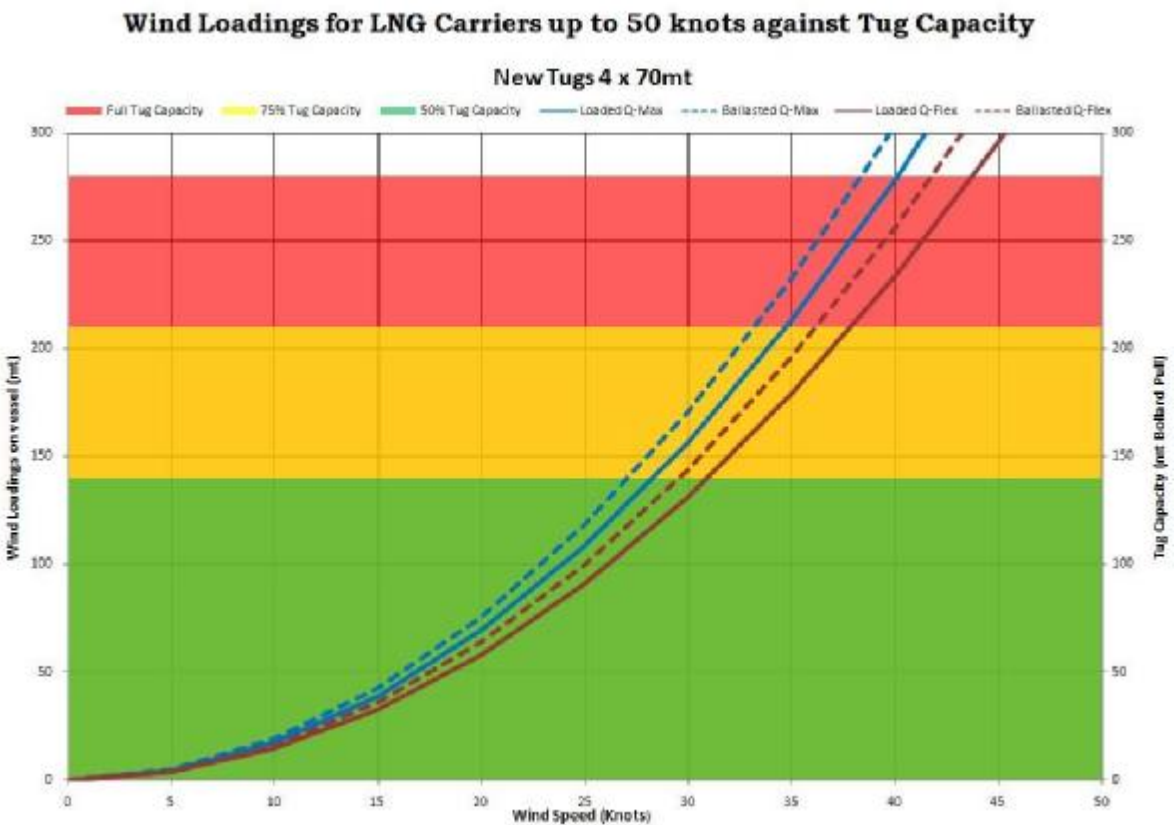
**Diagram 2: New Tug Fleet**

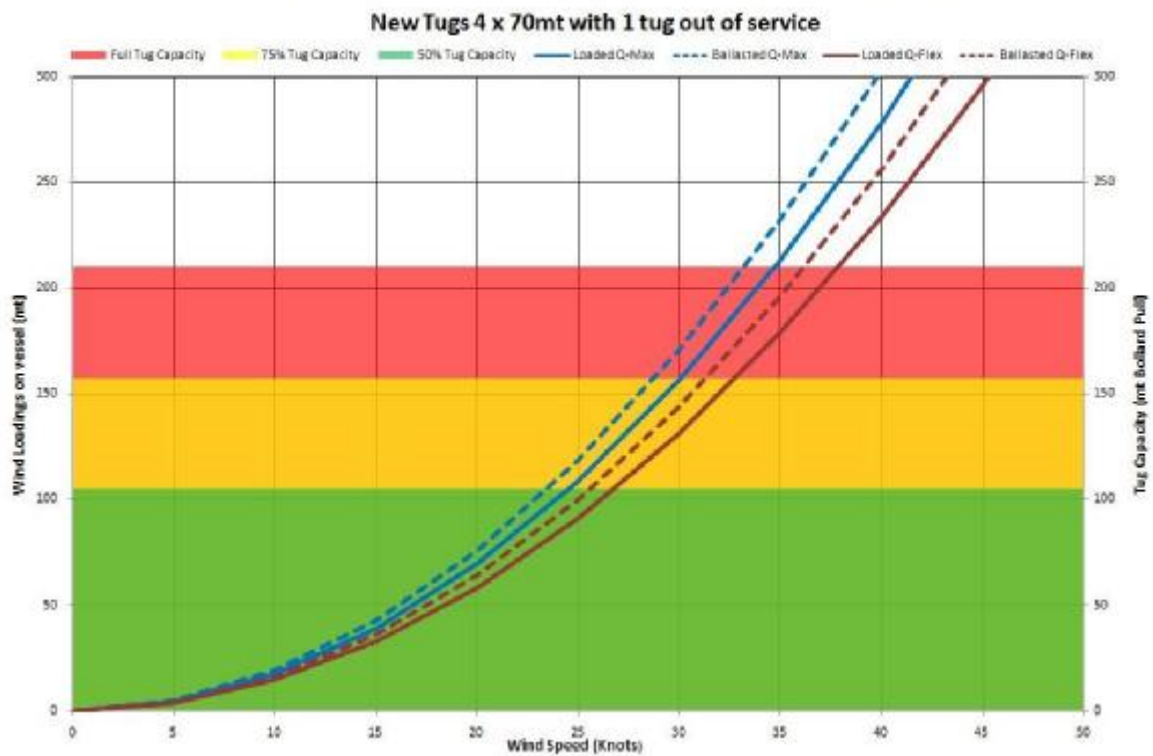
**Diagram 3: New Tug Fleet (one out of service)**

still be possible with mean wind speeds of 25 knots and maximum gusts of 30 knots.
